Re: Wisconsin Public Service Corporation
2008 PSCR Reconciliation
MPSC Case No. U-15402-R

In the matter of the application of)
WISCONSIN PUBLIC SERVICE CORPORATION)
for a power supply cost reconciliation proceeding) Case No. U-15402-R
for the 12-month period ended December 31, 2008.)

15 A. The purpose of my testimony is to present the results of WPS Corp's root cause investigation
16 of the October 6, 2007 lightning strike, forced outage and damage at Weston Unit 3.

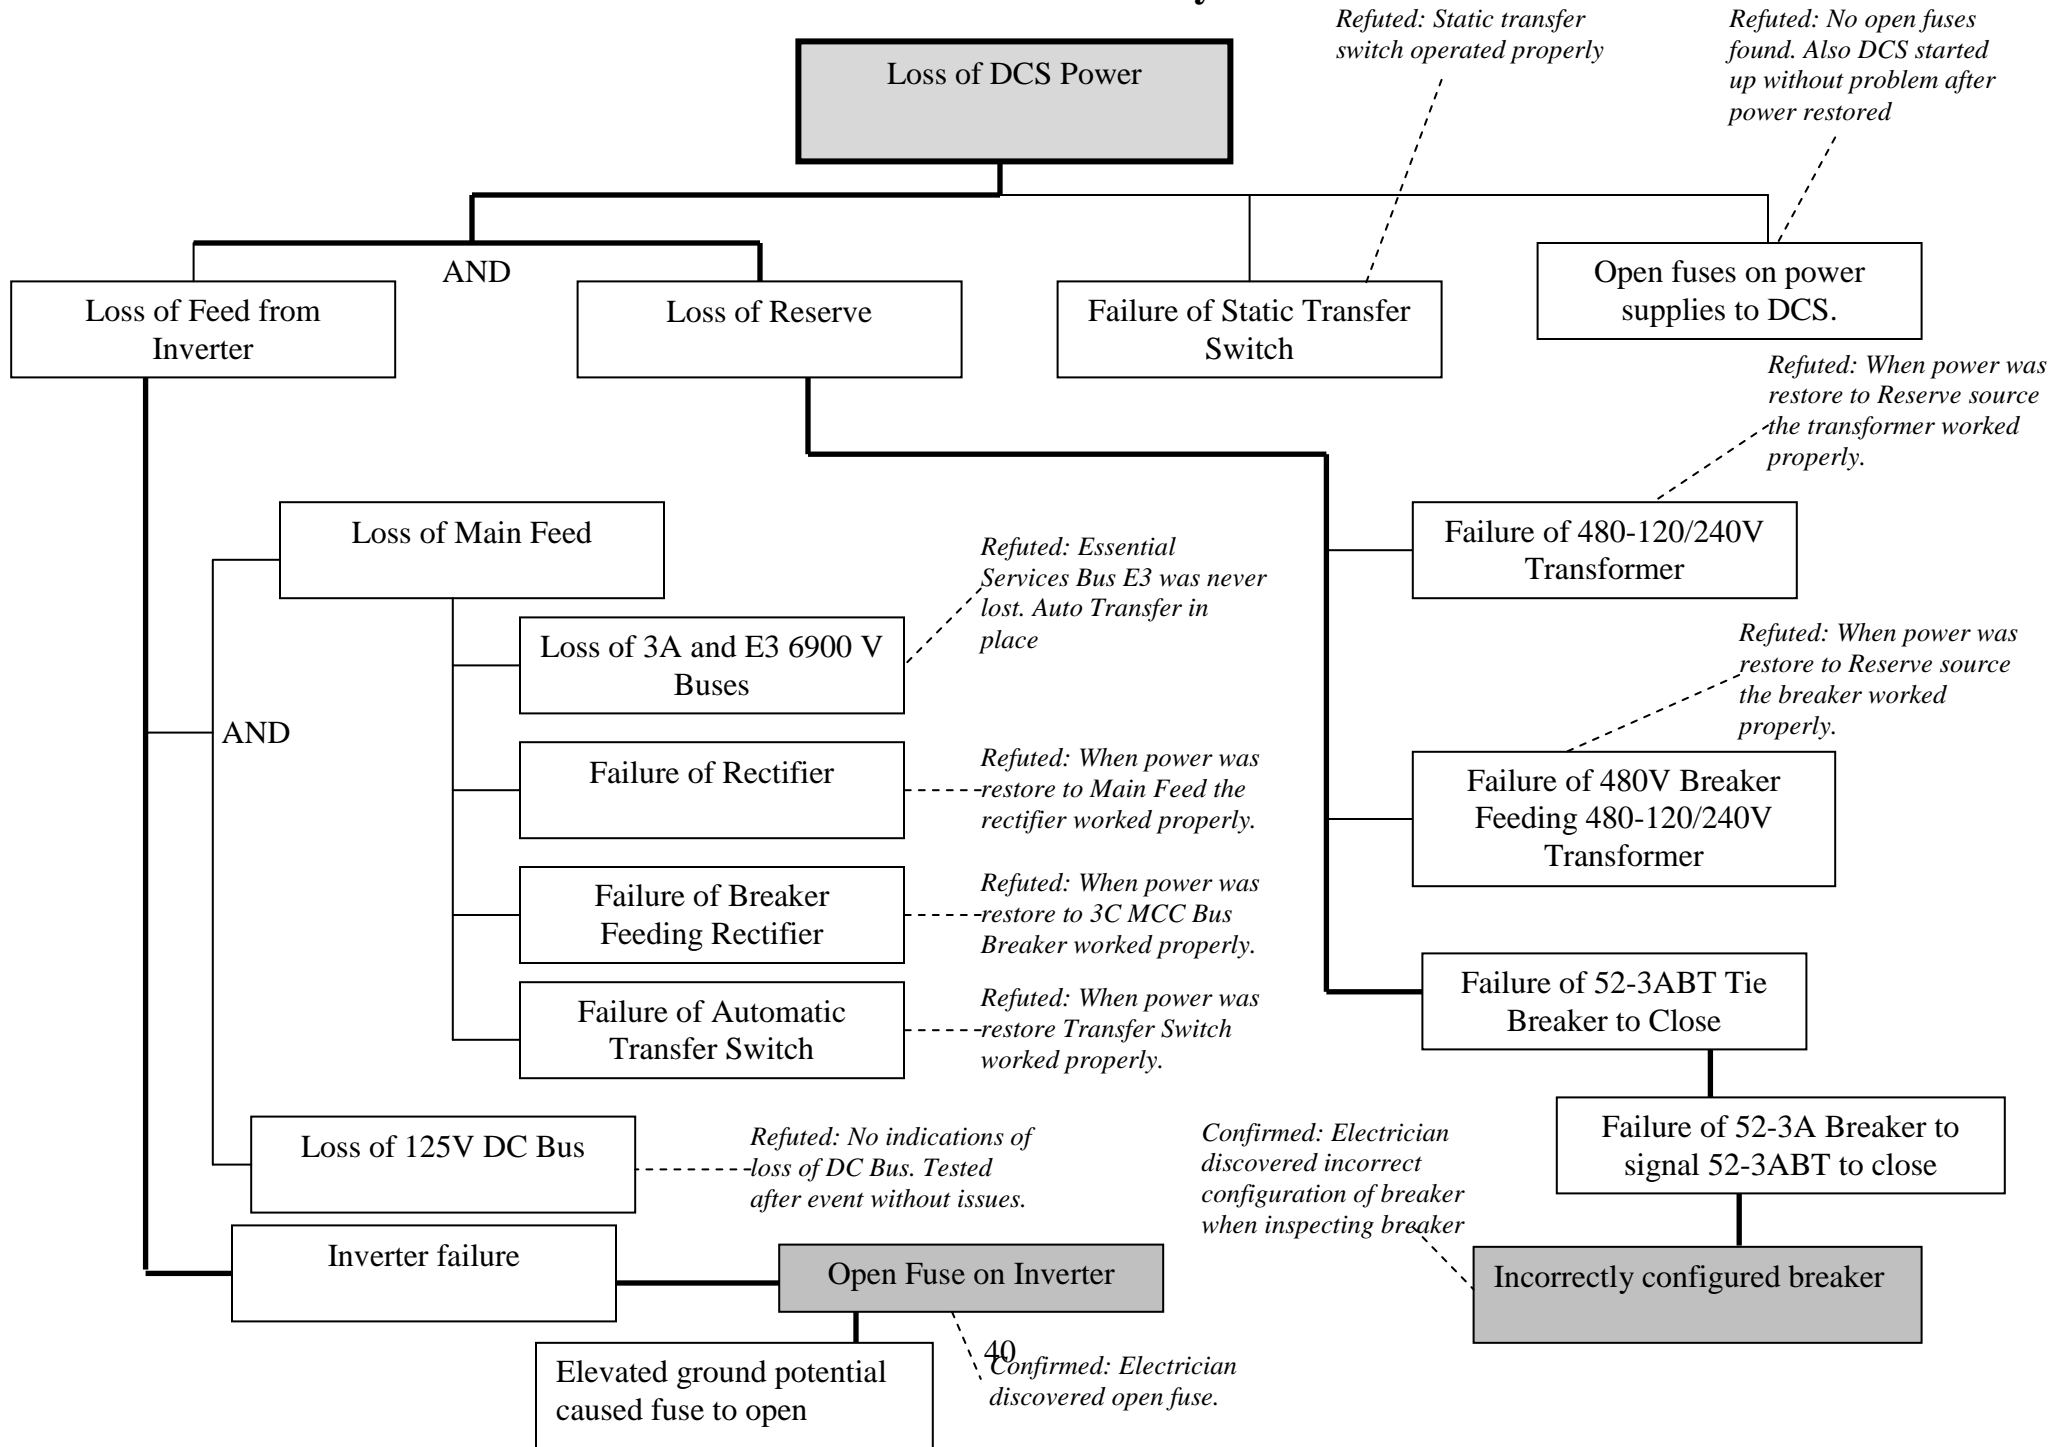
Loss of Distributed Control Systems

4 The second component affected by the power surge from the lightning strike was the fuse on
5 the primary circuit of the uninterruptible power supply (“UPS”) to the DCS, which controls the
6 plant’s operating equipment through a computer software program. When the power surge
7 caused this fuse, Fuse F204, to open, four of the five power supplies to the DCS were lost,
8 including a battery backup power supply. The fifth “reserve” power supply on a separate
9 circuit also failed due to a previously undetected circuit breaker control configuration error that
10 prevented another breaker from closing following the loss of the other power supplies. As the
11 result of these conditions, all power was lost to the DCS about 6 seconds after the turbine trip
12 and 52 seconds after the lightning strike.

14 The loss of DCS prevented its software logic from generating control signals to ensure a safe
15 and orderly coast down of the turbine/generator. These included signals to start the turning
16 gear oil pump and the emergency bearing oil pump. As the result, the turbine/generator
17 coasted down without sufficient bearing lubricating oil, causing the Babbitt bearing to melt,
18 which in turn resulted in damage to the turbine/generator shaft journals. The loss of the DCS
19 also shut off the generator hydrogen seal oil pump and prevented the startup of the
20 emergency hydrogen seal oil pump. Without seal oil, hydrogen exhausted from the generator,
21 ignited, and caused a fire on the turbine end of the generator and an explosion in the turbine
22 lubricating oil storage tank. Finally, the loss of the DCS caused the boiler feed pump
23 lubricating oil pumps to stop; damaging the boiler feed pump motors, hydraulic couplings, and
