Attached for filing is Indiana Michigan Power Company's (I&M) 2009 Power Supply Cost Recovery Reconciliation Case, Case No. U-15676-R, along with a proposed Notice of Hearing.

**NOTICE OF HEARING  
FOR THE MICHIGAN ELECTRIC CUSTOMERS OF  
INDIANA MICHIGAN POWER COMPANY  
CASE NO. U-15676-R**

**UNIT 1 MAIN TURBINE GENERATOR TRIP  
SEPTEMBER 20, 2008  
CONDITION REPORT (CR) 00838732**

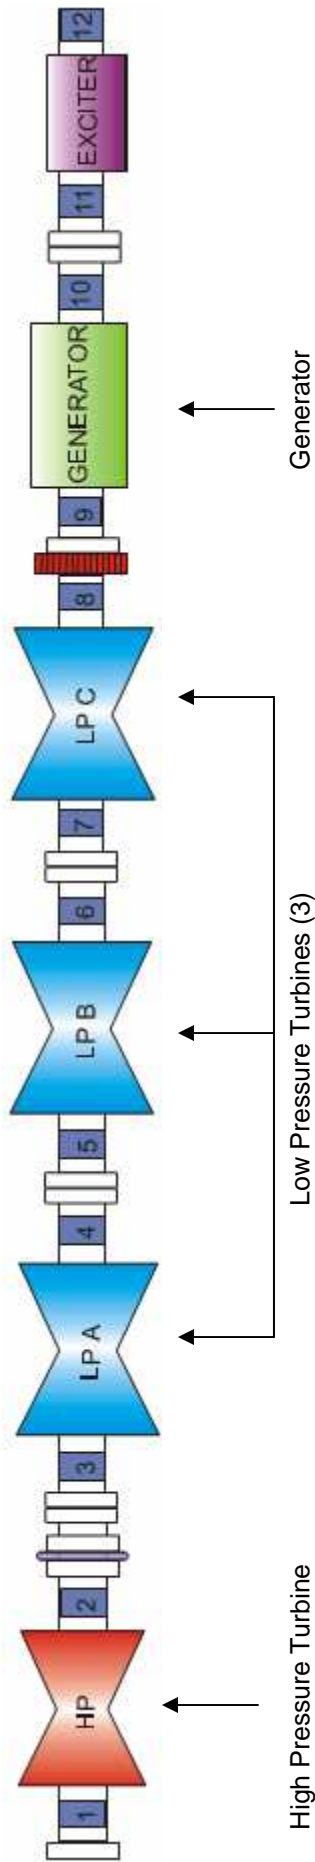
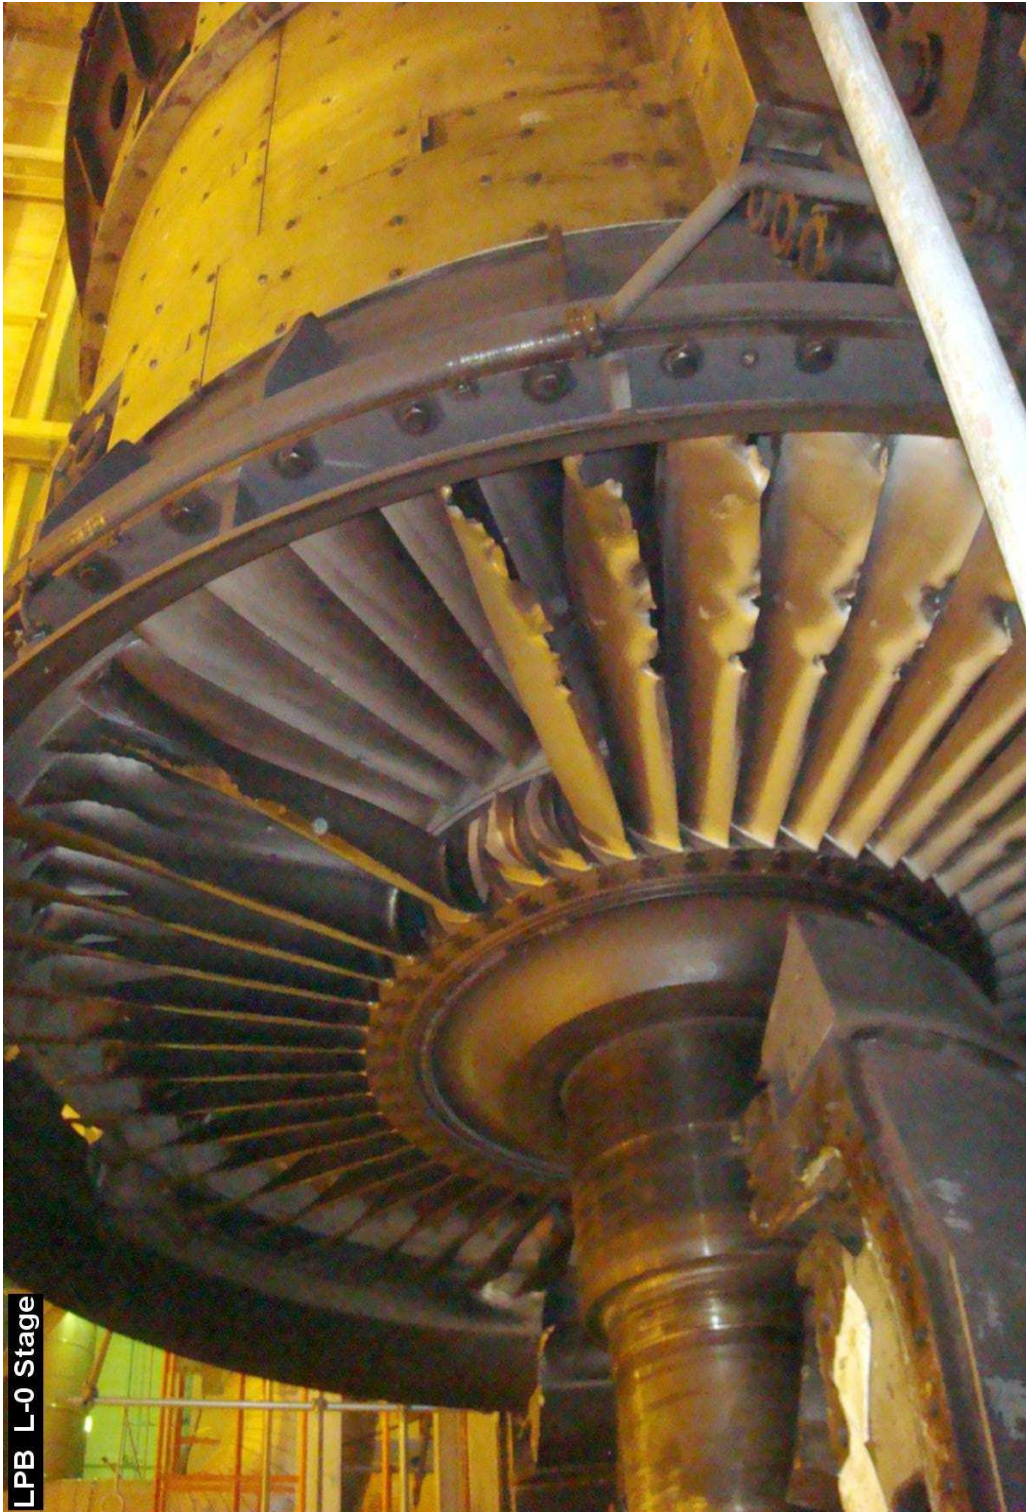
## Main Turbine-Generator Overview

15 A. Yes. I am sponsoring Exhibits IM-2 through IM-4. Exhibit IM-2 is a diagram of  
16 the Cook Plant Unit 1 turbine generator shaft line, Exhibit IM-3 is a picture of  
17 damaged L-0 blades on the low-pressure (LP) turbine, and Exhibit IM-4 is a copy  
18 of the Root Cause Analysis conducted by I&M.

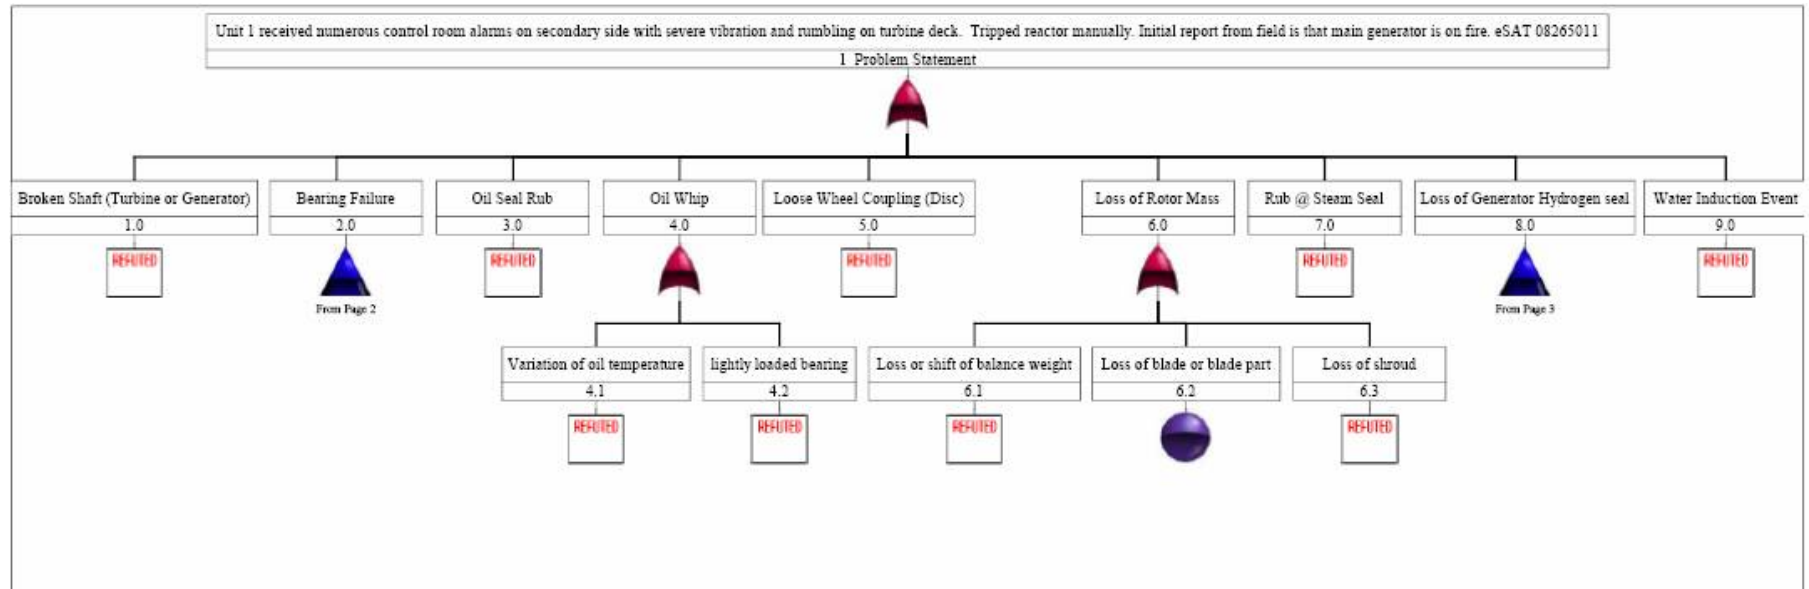
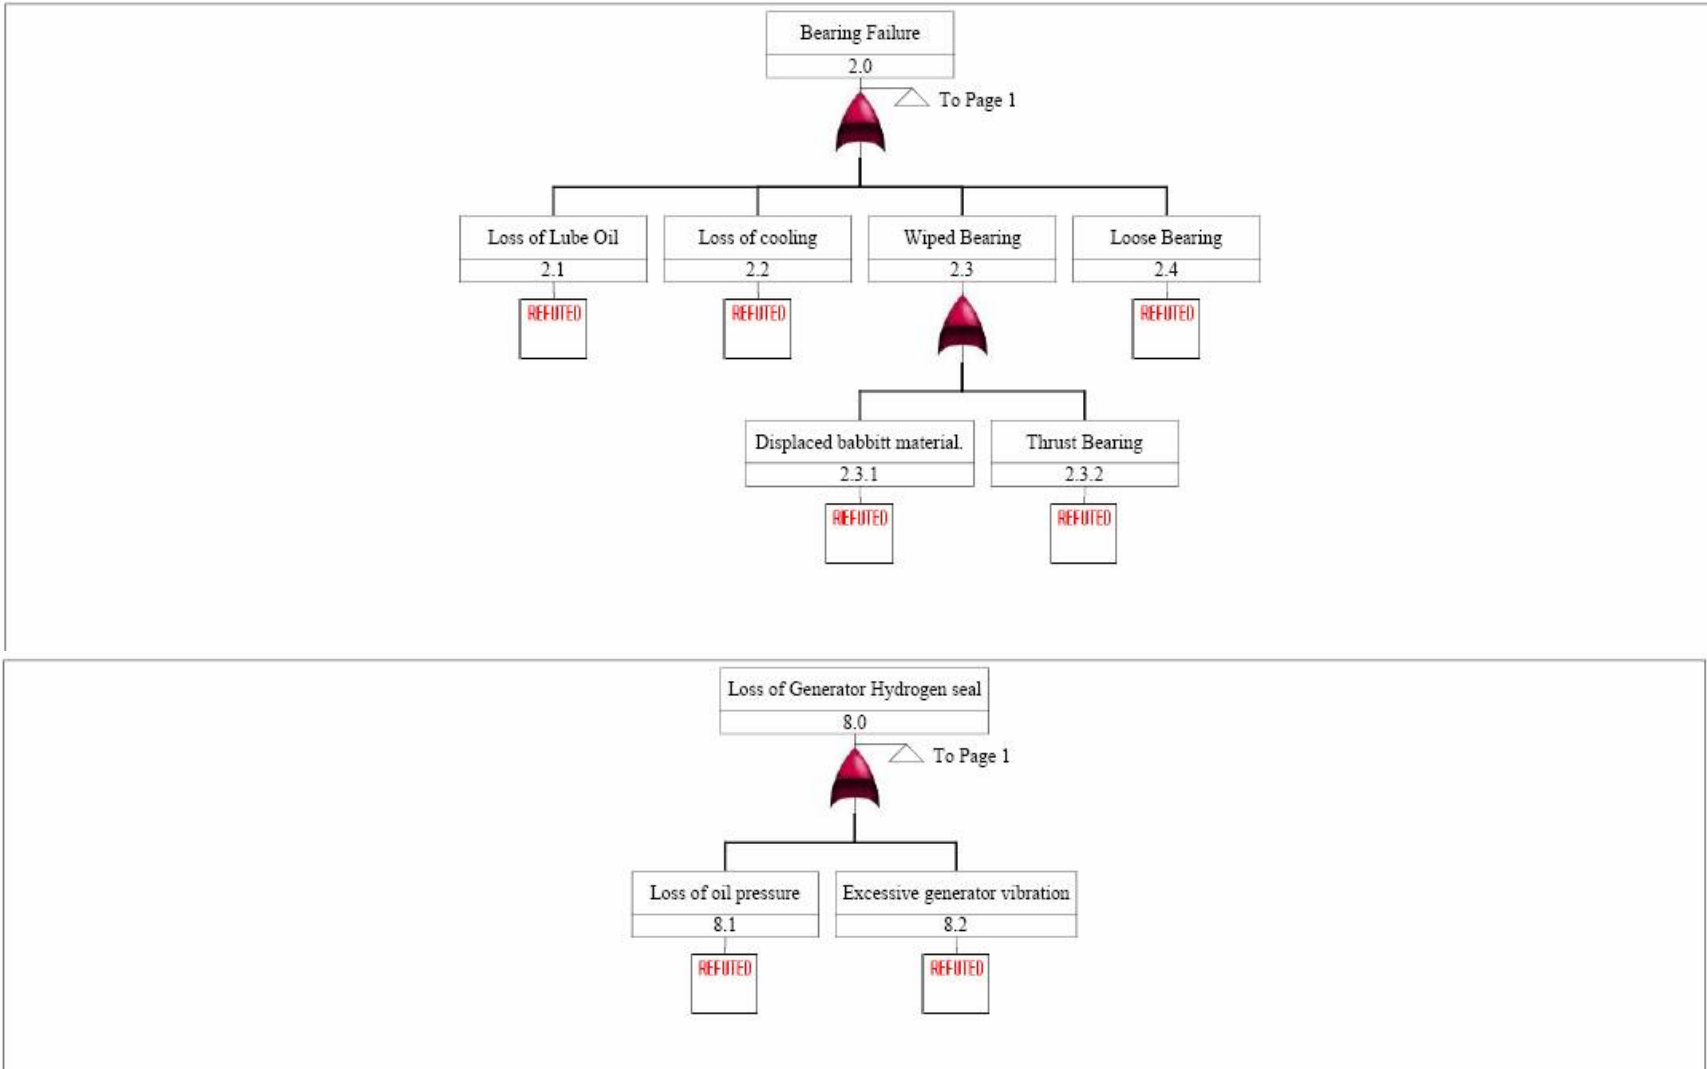
**6.3 FIP FAILURE MODE CHART**

The FIP Team Fault Tree and Support Refute analyses (refer to Attachments 6.3, and 6.4) determined that the high vibrations were initiated by a ‘loss of mass’ from the turbine. Specifically five Low Pressure (LP) Turbine blades were liberated, four L-0 blades from LP Turbine B, and one L-0 blade from LP Turbine C. The high vibrations resulted in significant equipment damage including;
