WOOD POLE MAINTENANCE SPECIFICATION

Engineering Standards Group

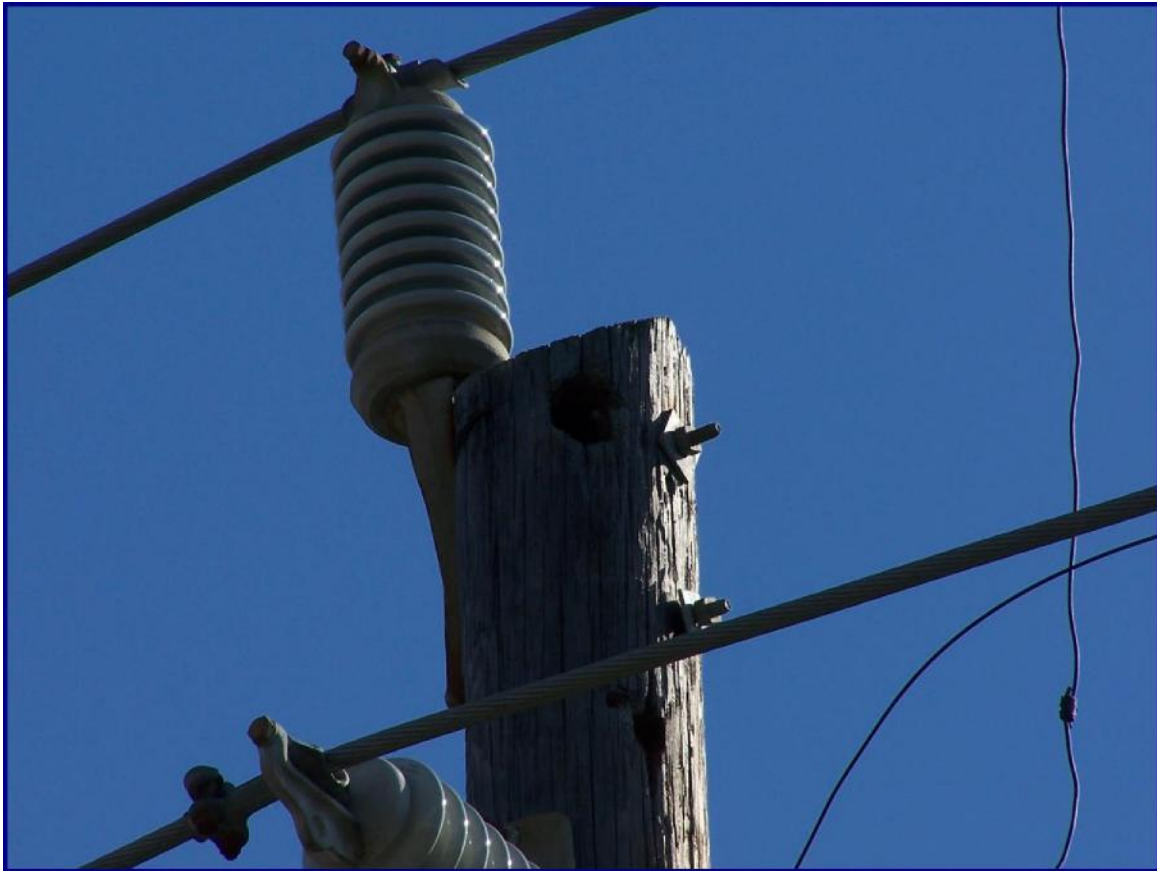
Light conditions have an impact on the inspection process, as seen in the picture below:

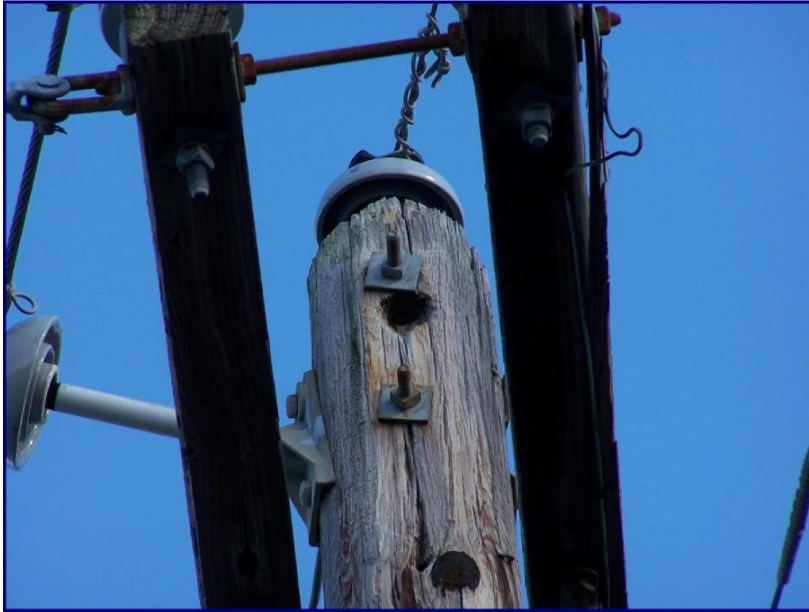
WOODPECKER HOLES:

Poles with woodpecker holes around bolt holes (peck out) and that do not affect the integrity of the hardware should not be considered for replacement based on the pole top condition.

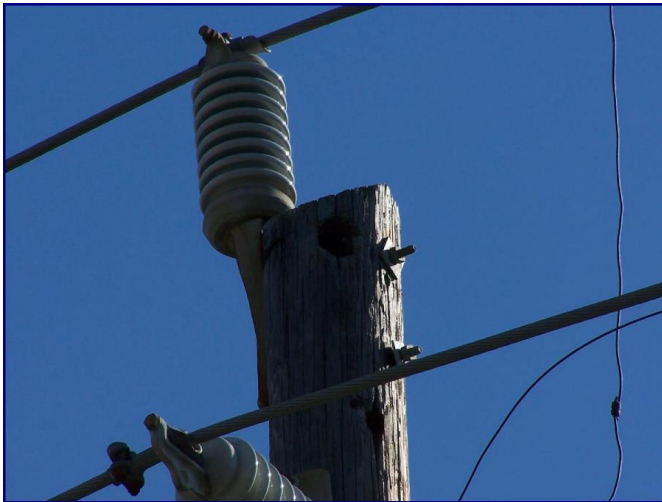
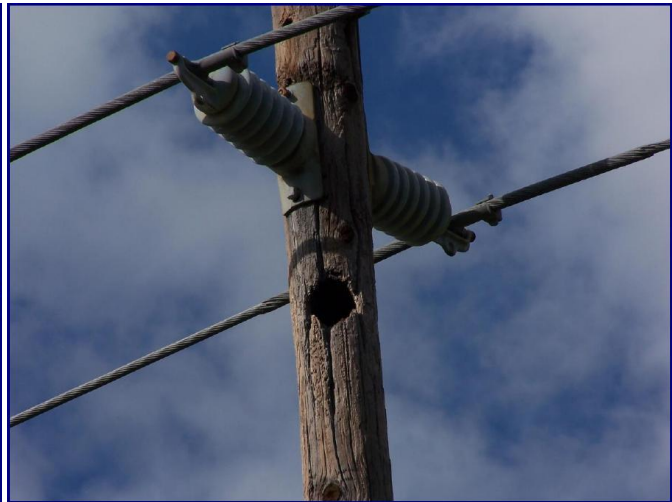
WOODPECKER HOLES:

Poles with woodpecker holes around or below the hardware that appear to be hollow or the back of the hole can not be determined are recommended for replacement.

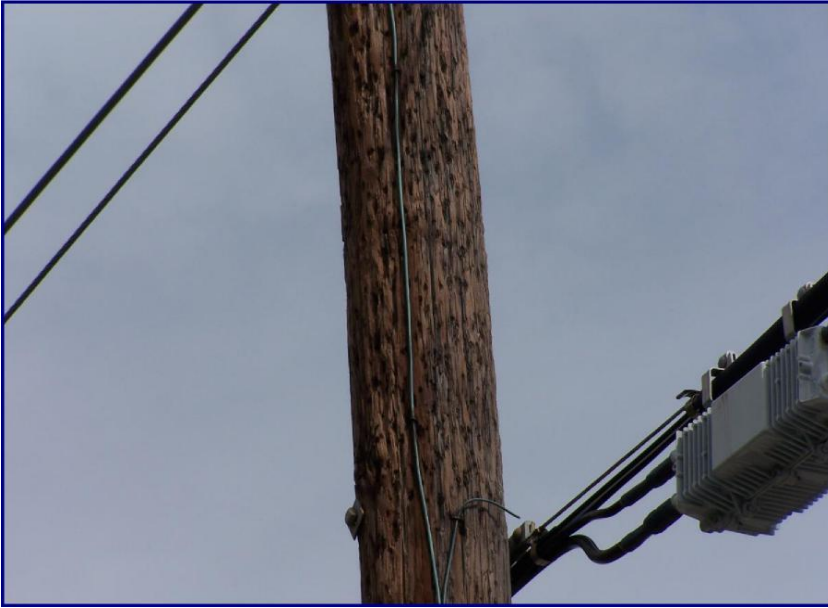
Pole with moderate damage as a result of spur cuts from excessive climbing should **not** be considered for replacement based solely on this condition. Spur cuts that are moderate should be noted under other pole conditions.

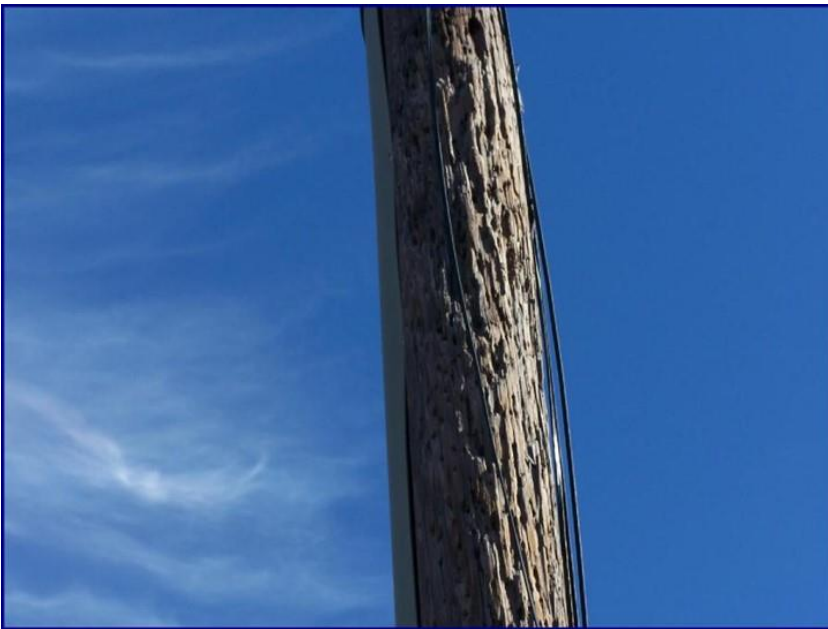
SPUR CUTS:

Pole with severe spur cut damage as a result of excessive climbing, are recommended for replacement based on this condition. Damage that results in a minimum of 1 inch of the poles outer shell being removed should be considered for replacement.

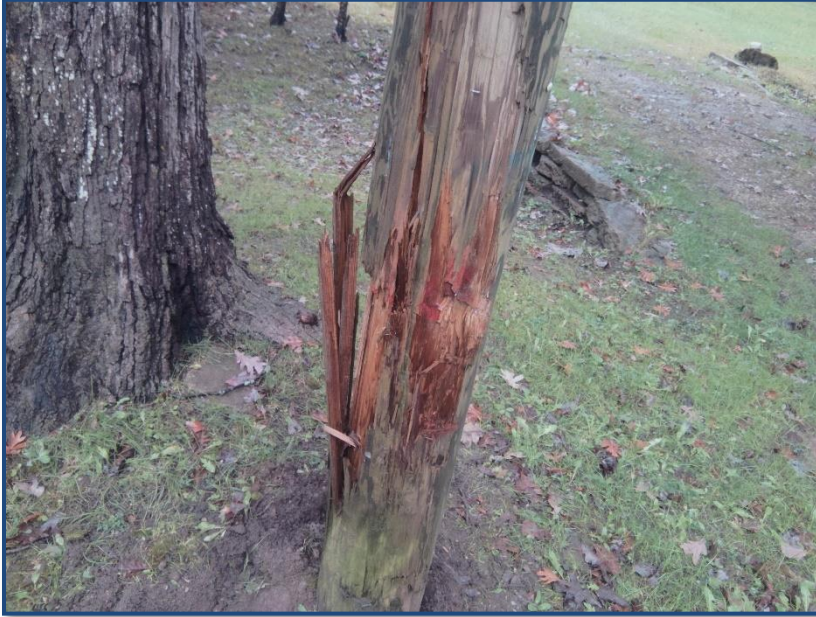
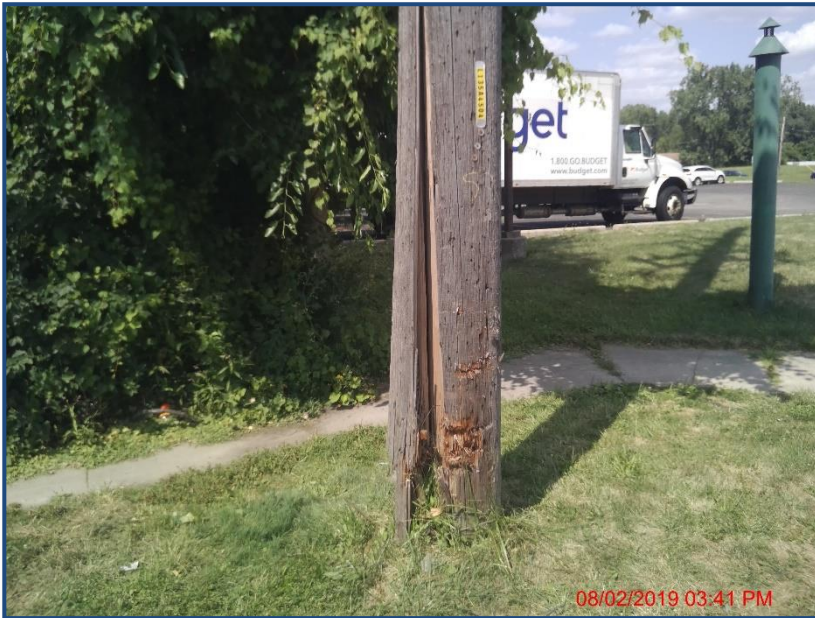
MECHANICAL DAMAGE:

Pole with moderate damage as a result of vehicles, non-environmental factors, or vandalism that are from the result of man-made forces from accidental or purposeful actions. Moderate mechanical damages can be defined as damages that will cause question of the structural integrity of the structure such as structure shell loss or large cracks. Damage that results in a minimum of 1 inch of the poles outer shell being removed should be considered for replacement.

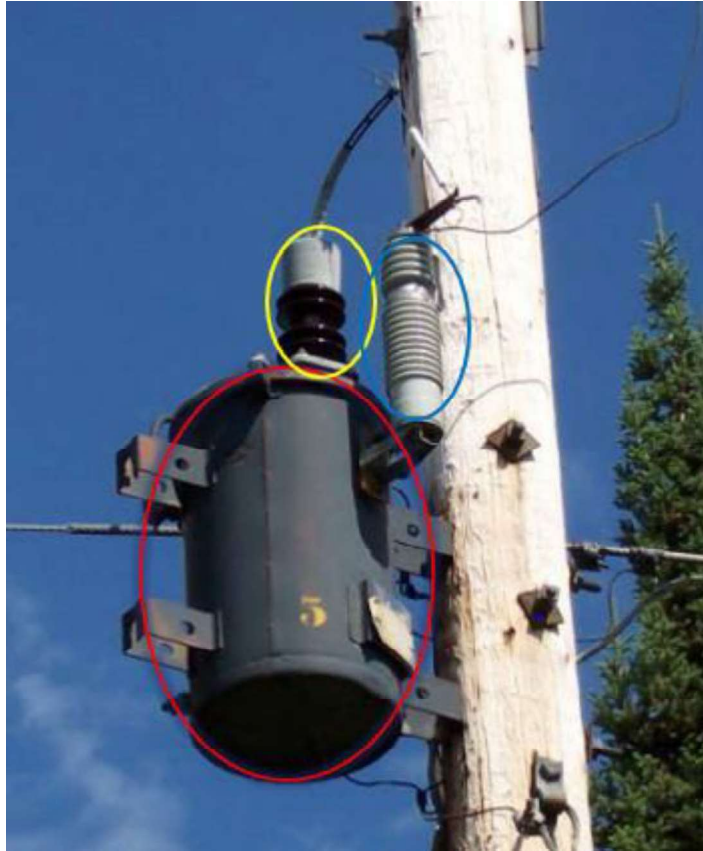
An example of a dark shaded transformer with porcelain insulators that have a shine during daylight.

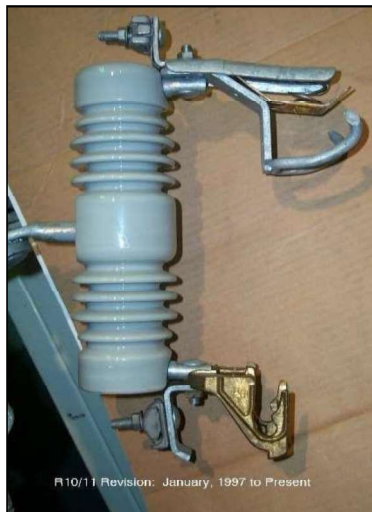
Porcelain Cutouts: S&C R9, R10, AB Chance Cutouts

All porcelain cutouts must be replaced; only polymer cutouts are the current standard. Polymer cutout should be replaced if the cutout is burnt, melted, and arcing. More reference on EB-2005-OH-05 / EB-2005-OH-05

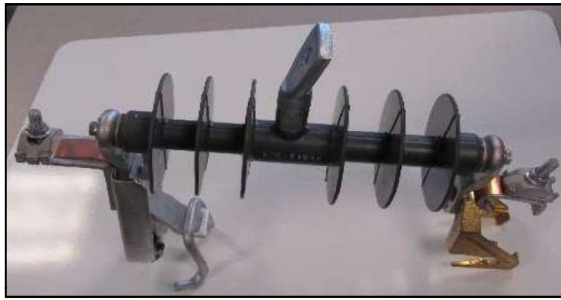
Acceptable Hubbell Power Systems Polymer Cutout

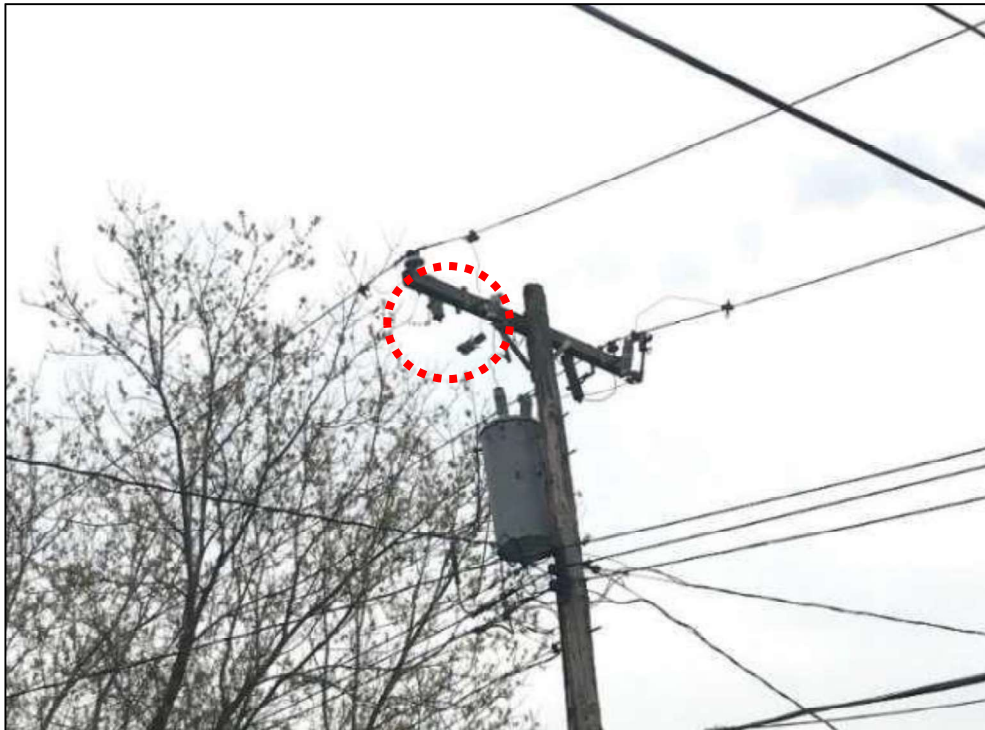
Also look for broken cutouts as shown below:

Broken S&C Porcelain cutout just above the transformer

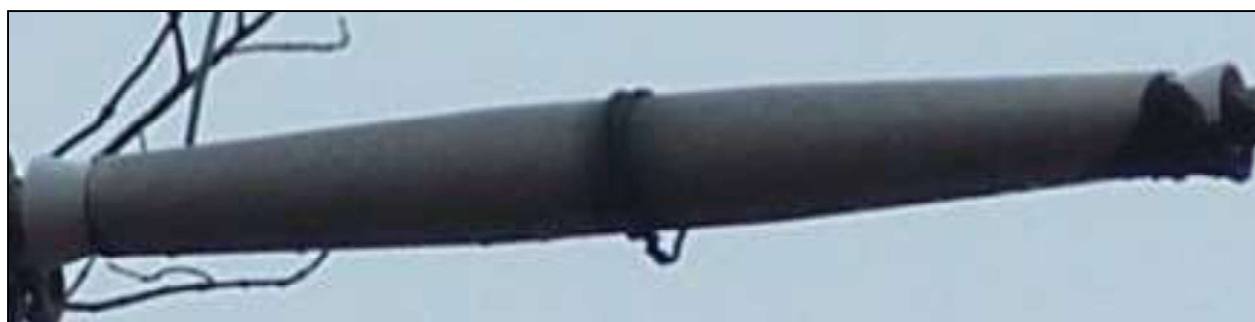
Automatic Sleeve to be reported.

Any automatic sleeves must be replaced; the current standard is the compression sleeve. Compressionsleeves must be replaced if the conductor, on either side, has a broken wire. Reference EB-2014-OH-10

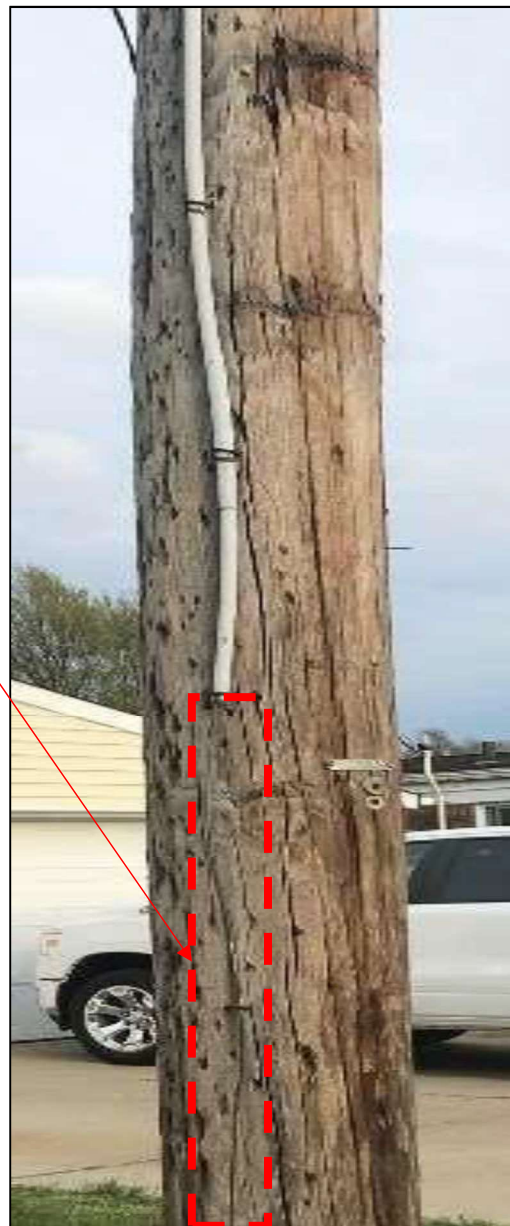
Defective Ground Wire (non-continuous)

Any missing ground wire, must be replaced. The ground wire goes inside the plastic molding and must be continuous from the top of the pole to the ground. In the case described below wire and molding should be replaced.

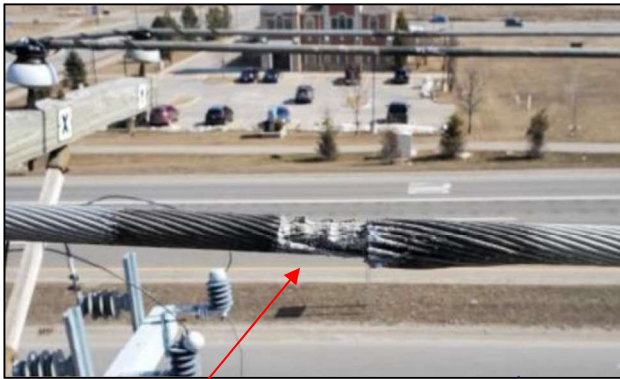
Burned Conductor

All smart fault Indicators that show signs of burning on either the conductor wire or sensor needs to be reported and replaced. Sensor will typically show signs of damage on the duckbill and eyebolt. Attached are photos of the burned conductors and sensors.

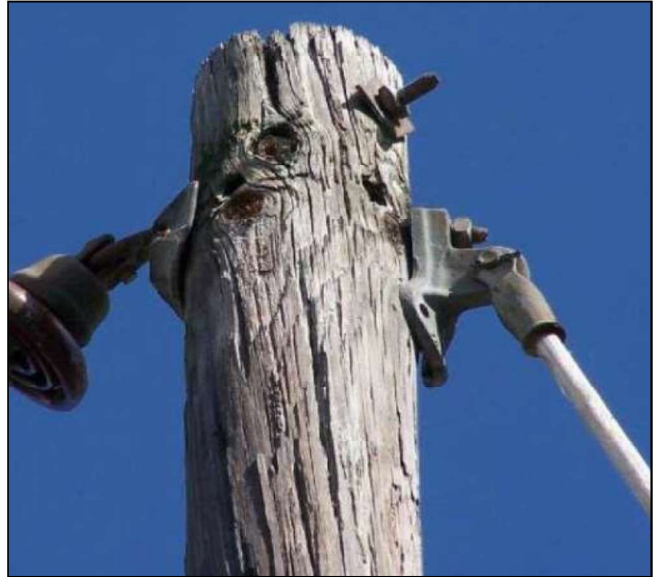
Acceptable Pole Top

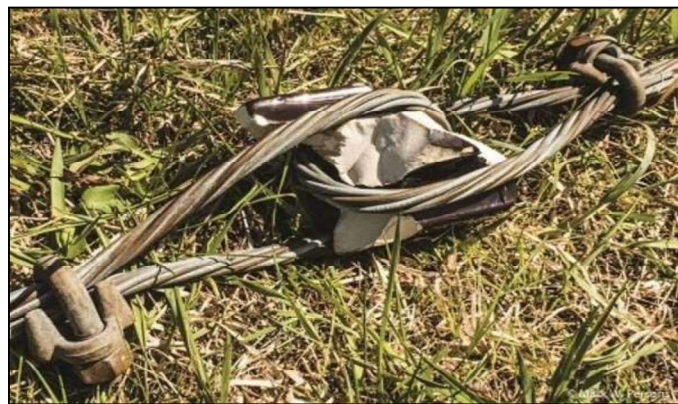
Defective Johnny Ball

Guy wires: To be reported if broken strands are observed or it is loose. **Johnny Ball:** To be reported if it's broken or disconnected.

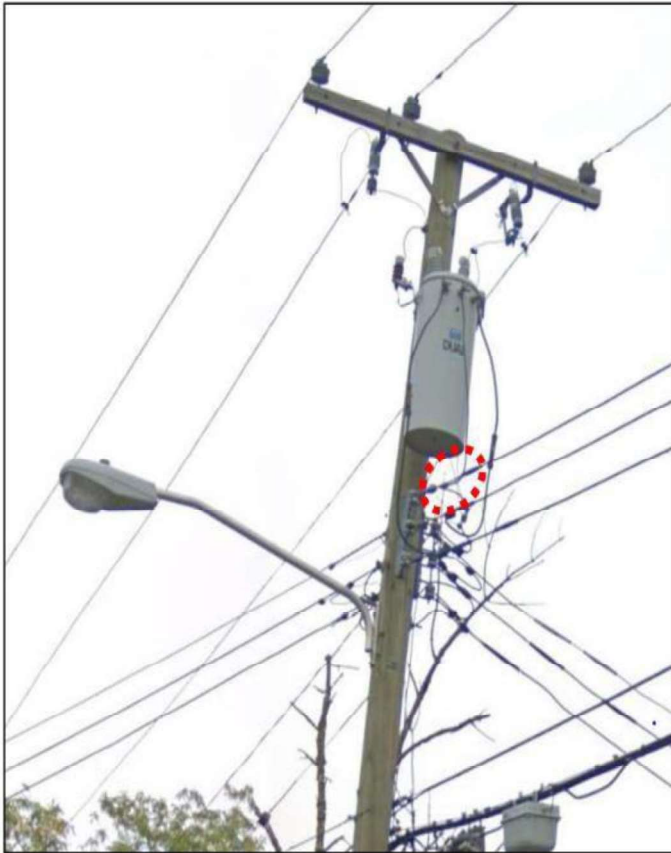
Acceptable Neutral Tap on Secondary

Neutral should be reported if it's disconnected. For more details see the diagram below.

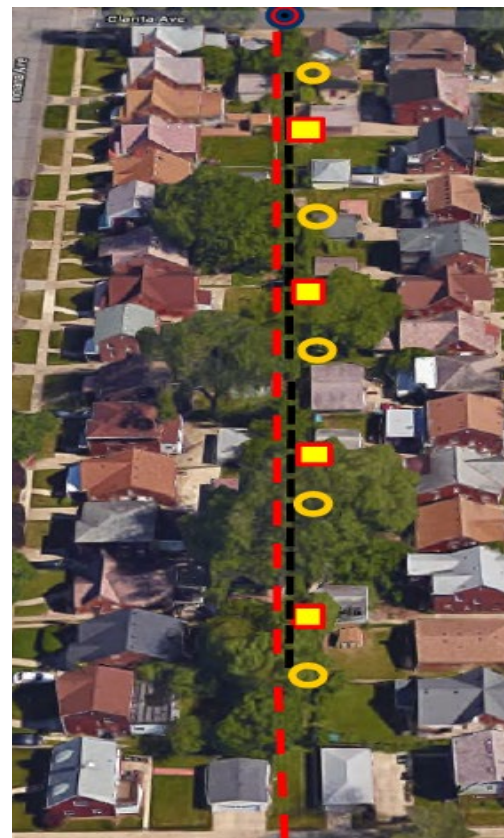
*A More Focused View of the North Block in the Two Block
Appoline Pilot Area Shown to the Left*

Figure 1 illustrates the scope of the pilot project. Appoline is a 4.8kV circuit that will be converted to 13.2kV at some point in the future, therefore the pilot project is being constructed to the higher

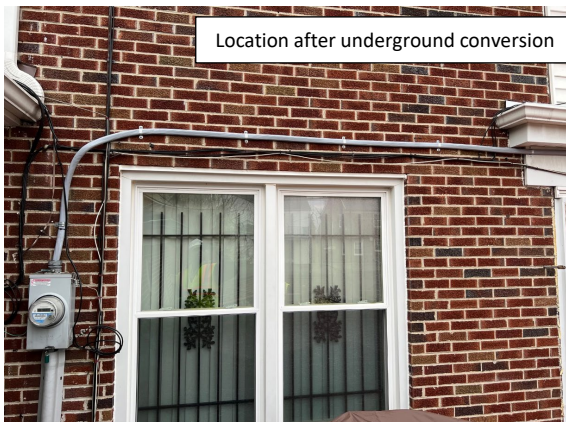
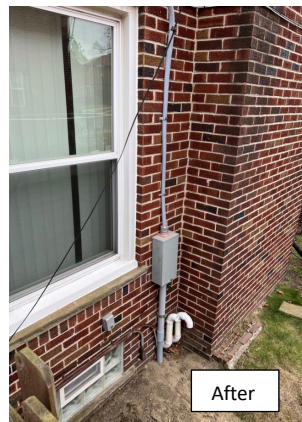
Appoline customer connections – before and after

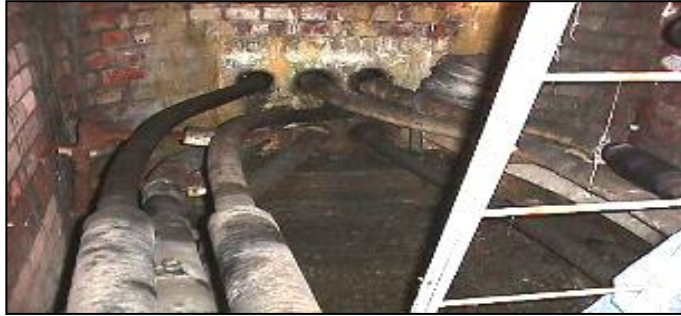
System Cable miles by voltage class

About 35% of our system is underground and primarily uses two main types of cable – System Cable and Underground Residential Distribution (URD) cable

- Most frequently used leaving substation underground regardless of voltage
- Pulled through conduit (duct banks)

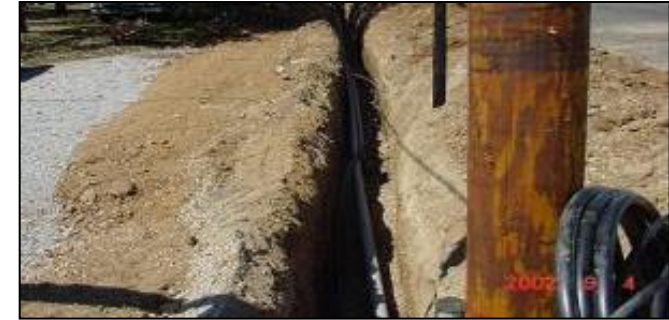
URD miles by voltage class

- Direct buried cable in residential subdivisions between transformers
- All new subdivisions since 1970s are fed by URD
- Even when served from a URD, often part of the circuit is fed from the overhead

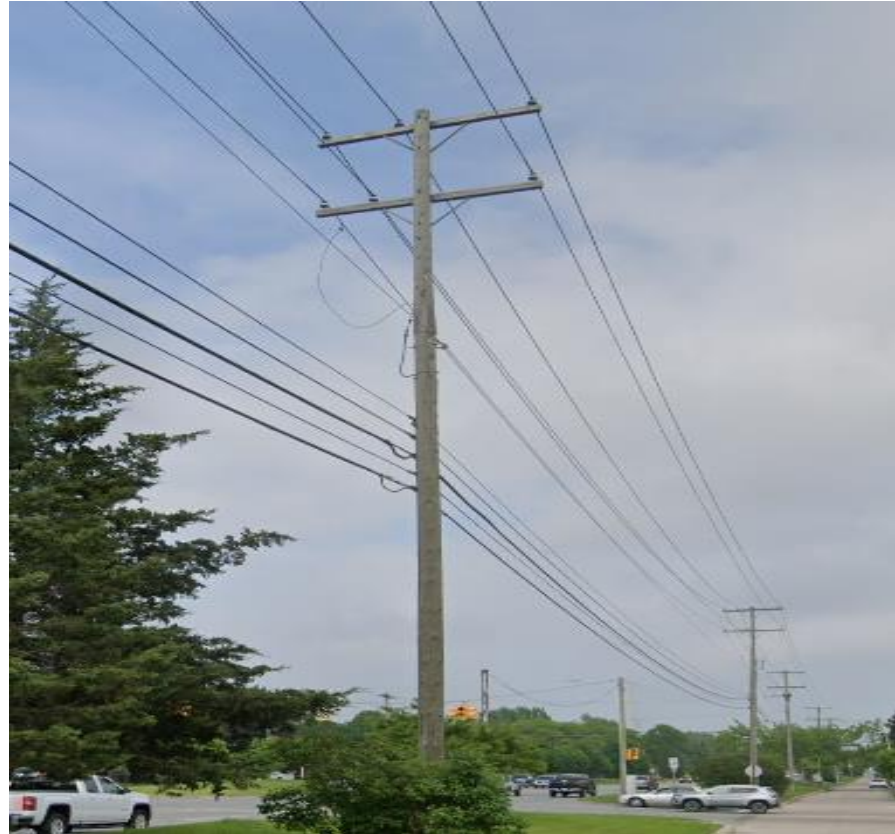
Overhead Circuit Miles

The most visible part of the distribution system has ~28,500 miles of overhead circuits with, 16,700 miles operating at 4.8kV

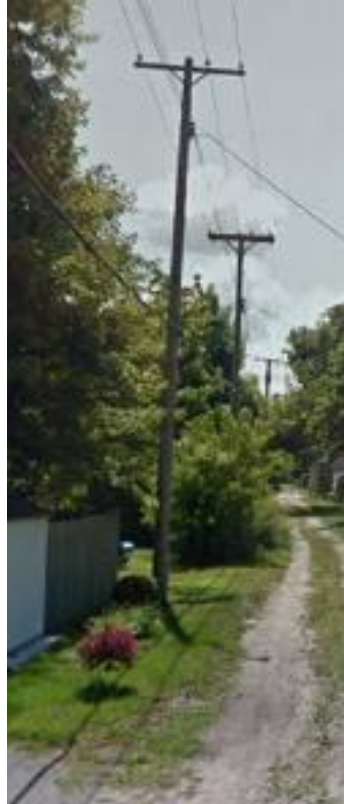
Construction of the three phase leads are similar across voltage type, and may be either in the rear lot or near road right of way; 4.8kV poles are often shorter and require less clearance

4.8kV System

Rear Lot

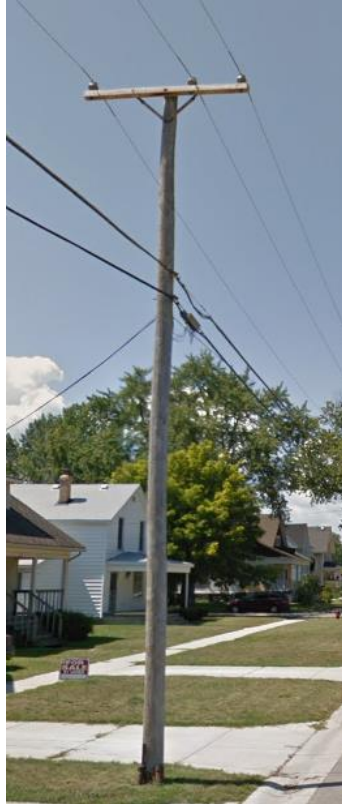
Road right-of-way

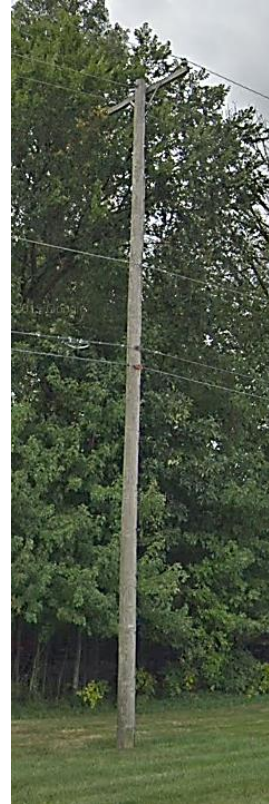
13.2kV System

Rear Lot

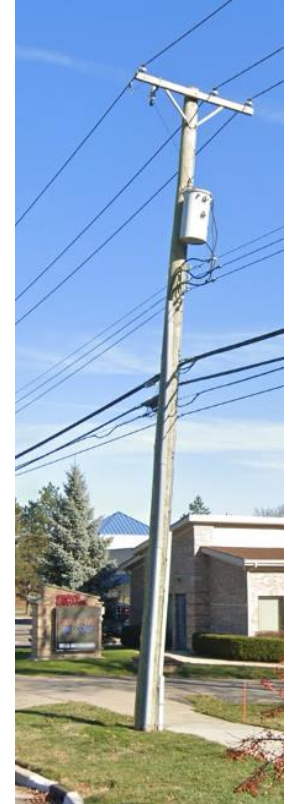
Road right-of-way

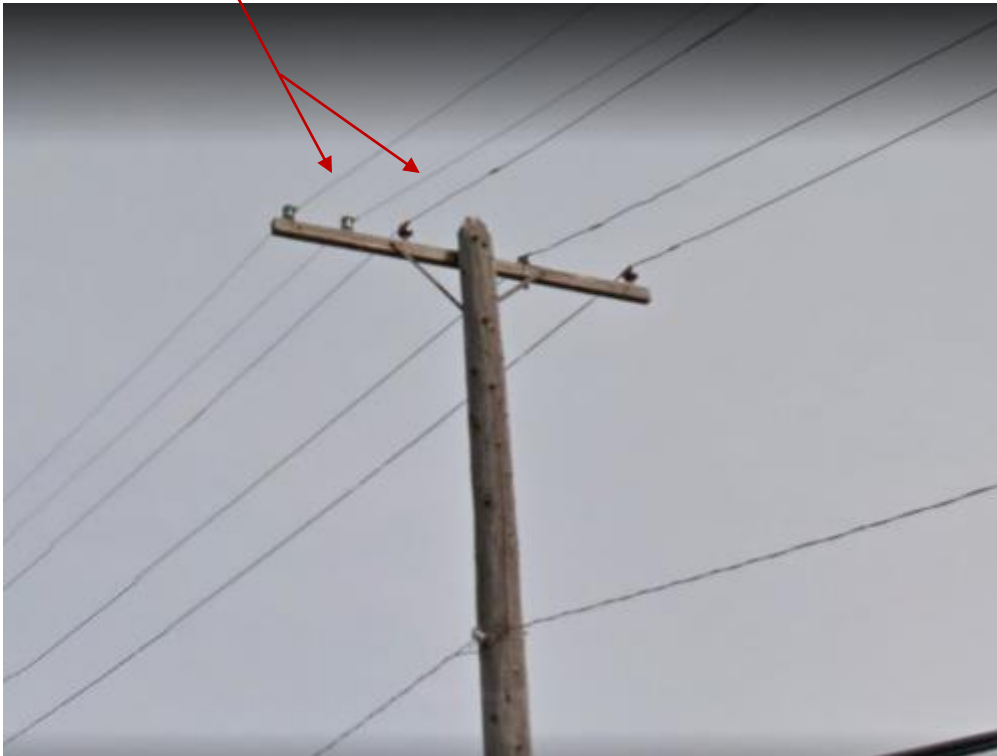
The Public Lighting Department (PLD) Arc Wire System was used to supply electricity to arc-type streetlamps and share utility poles with DTE Electric distribution

- Those streetlamps are no longer used, but large amounts of arc wires are still attached to utility poles
- The abandoned wire poses a risk if it becomes energized by making contact with DTE facilities
- In 2017, we estimated that there were approximately 1,300 miles of DPLD arc wire that was intermittently co-located among DTE Electric's 2,400 miles
- An average DTE Electric circuit in the City of Detroit is expected to have arc wire co-located on about 50% of the poles

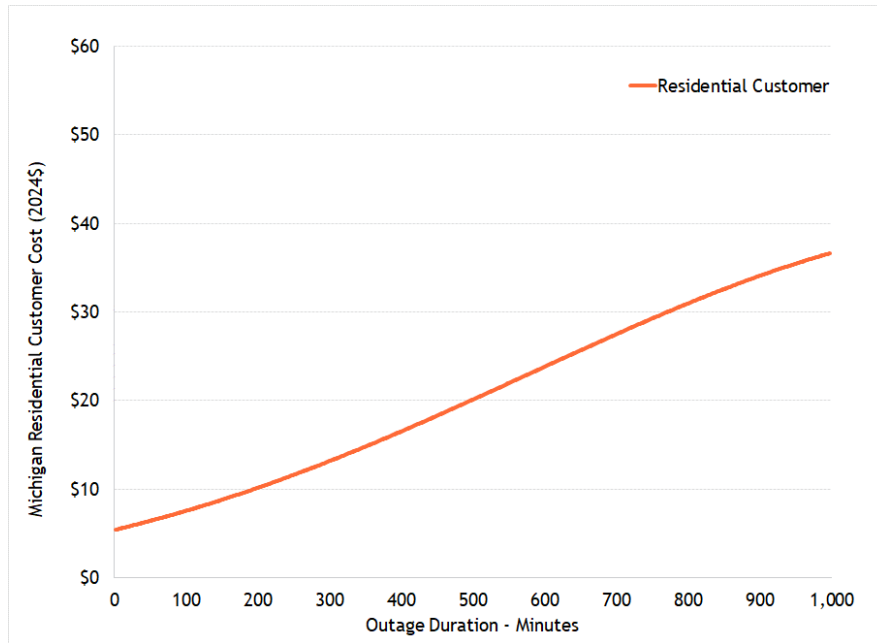
Figure 4-4 Michigan Residential DOE ICE Calculator Values

The calculator includes the estimated interruption costs for residential, small C&I, and large C&I customers for a range of durations. Figure 4-4 shows the cost of interruptions for residential Michigan customers and Figure 4-5 shows the cost of commercial and industrial customers in terms of cost per customer per outage.

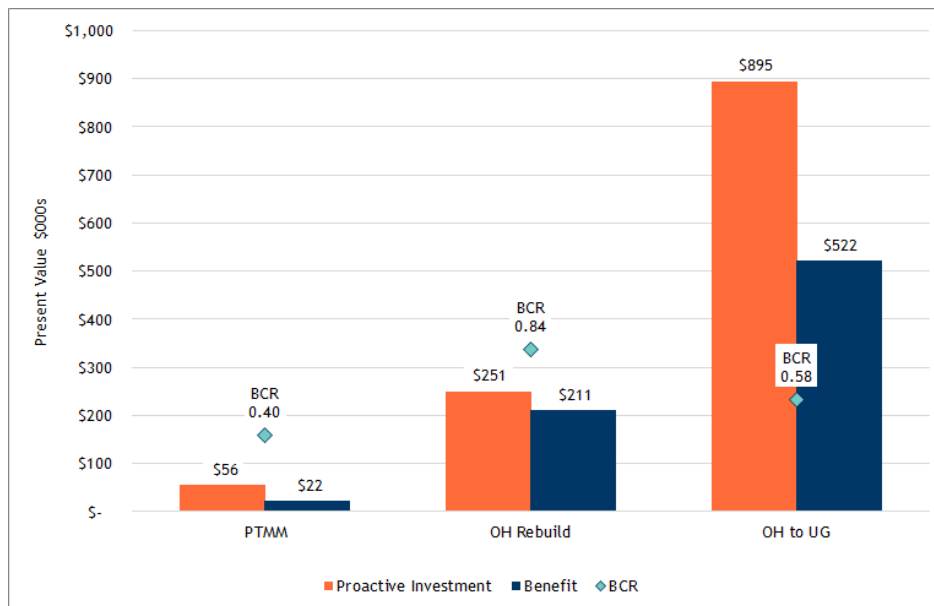
Figure 5-2 Appoline BCA Results

The results for both project models are shown in Figure 5-2 and Figure 5-3, respectively. For both projects, the Overhead Rebuild investment option has the highest BCR. The BCRs for the PTMM option for both projects are less than 1.0. This is mainly due to relatively low customer density and absence of non-residential customers being served by the assets.

The BCRs for undergrounding on both projects are less than 1.0; however the model does not account for unique and less tangible values brought by undergrounding when compared to other investment options, including:
