RE: In the matter of the Application of **DTE ELECTRIC COMPANY** for authority to increase its rates, amend its rate schedules and rules governing the distribution and supply of electric energy, and for miscellaneous accounting authority
MPSC Case No. U-21534

WOOD POLE MAINTENANCE SPECIFICATION

Engineering Standards Group

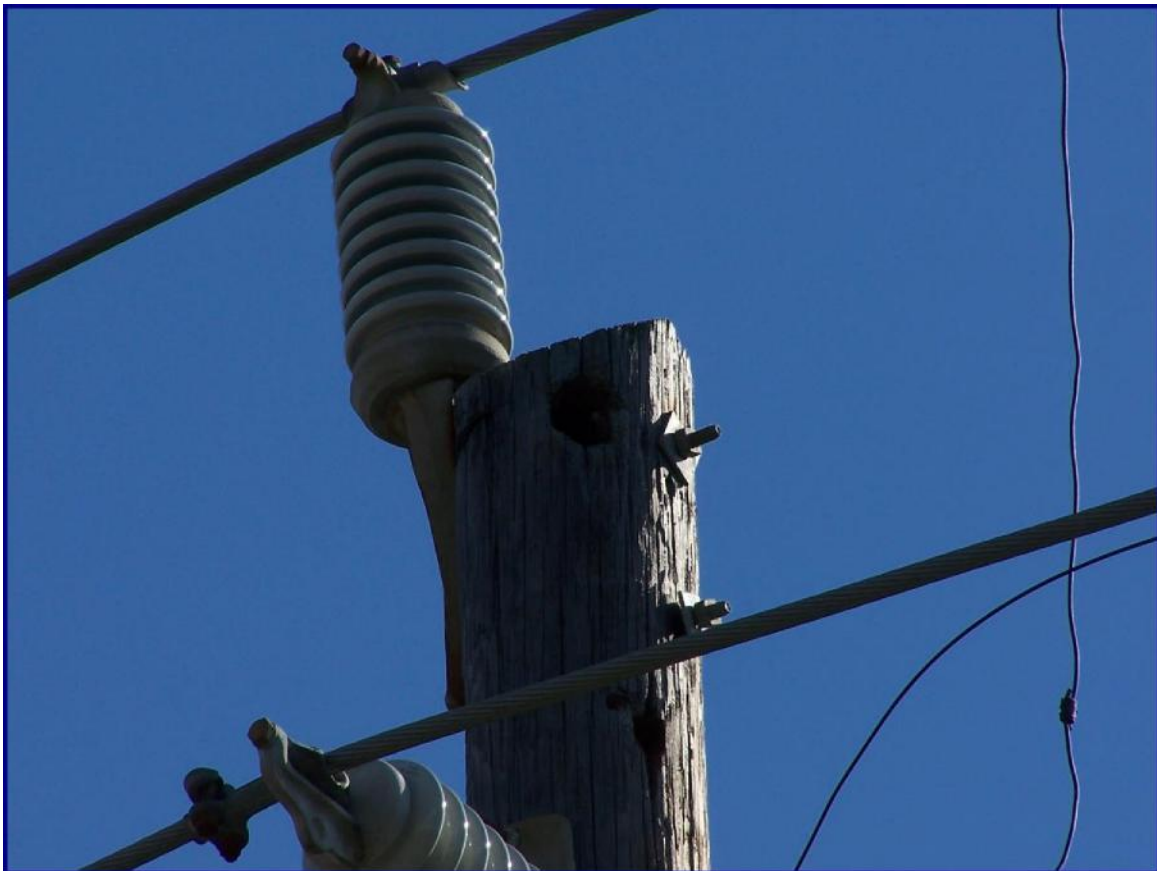
Light conditions have an impact on the inspection process, as seen in the picture below:

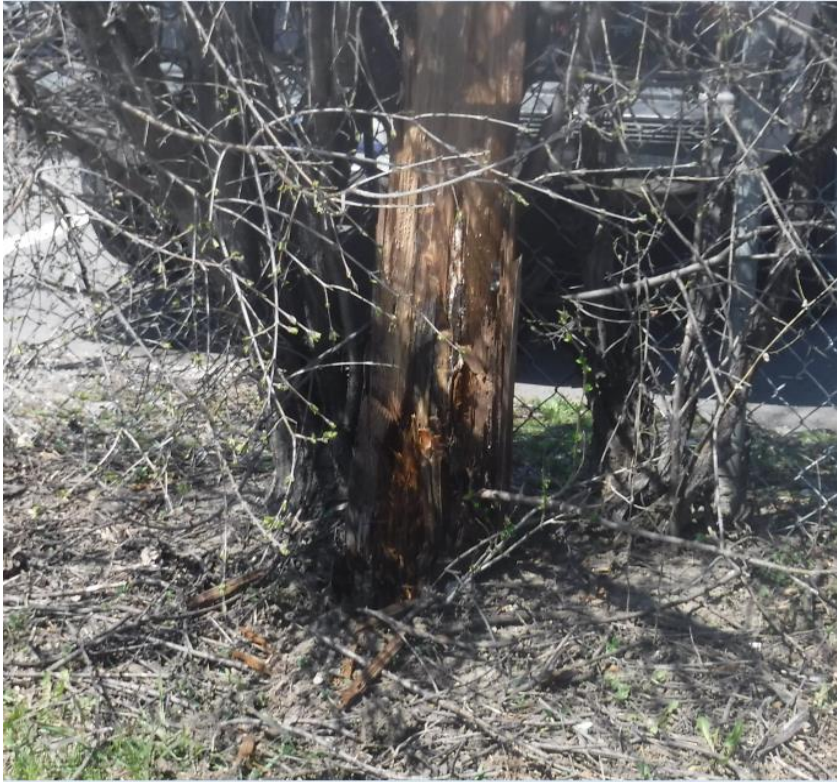
Poles with extensive shell rot or surface decay that affect the integrity of the pole is recommended for replacement.

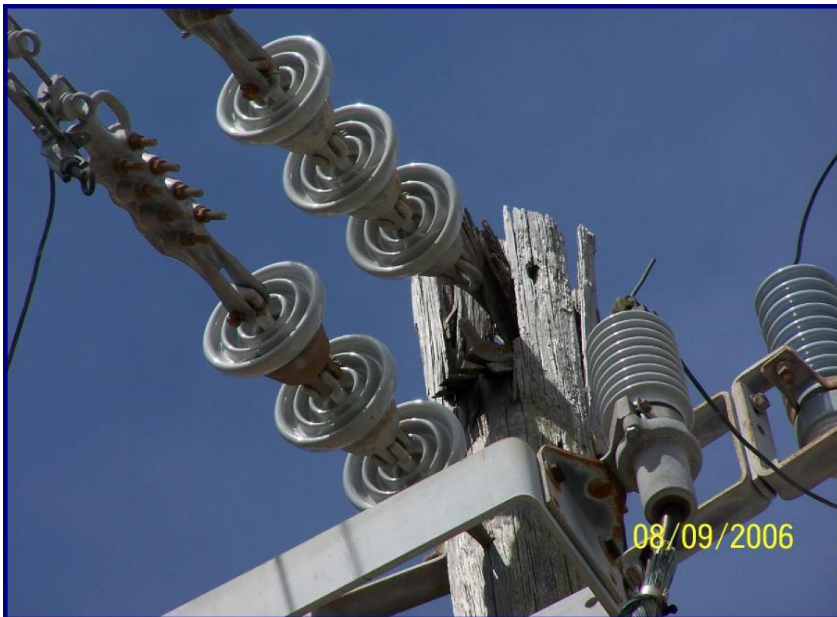
DECAYED TOPS:

Poles with decay conditions that affect the integrity of hardware is recommended for replacement, regardless of ground line conditions.

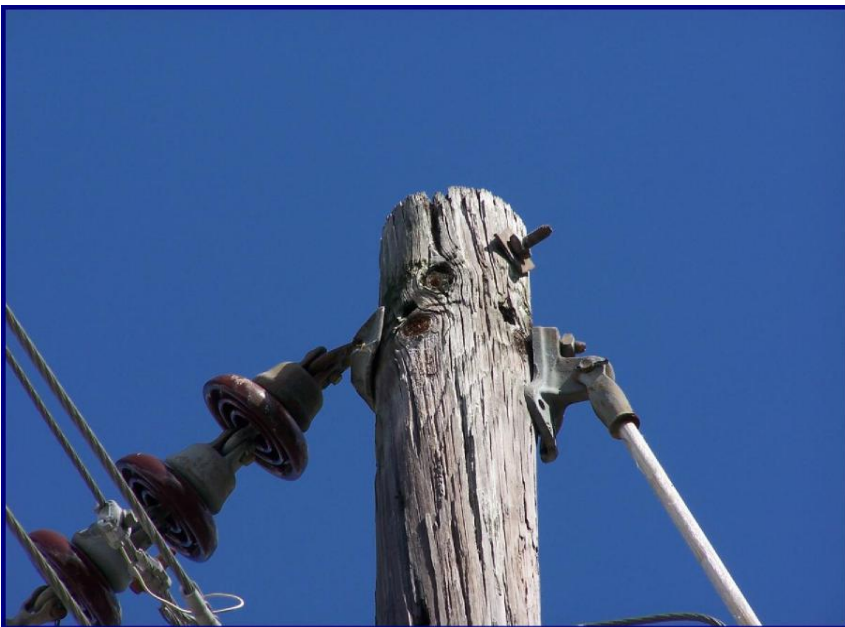
DECAYED TOPS:

Poles with decayed tops where there is evidence of crowning and/or decay that is not in close proximity of through bolts or hardware should not be considered for replacement based on the pole top condition.

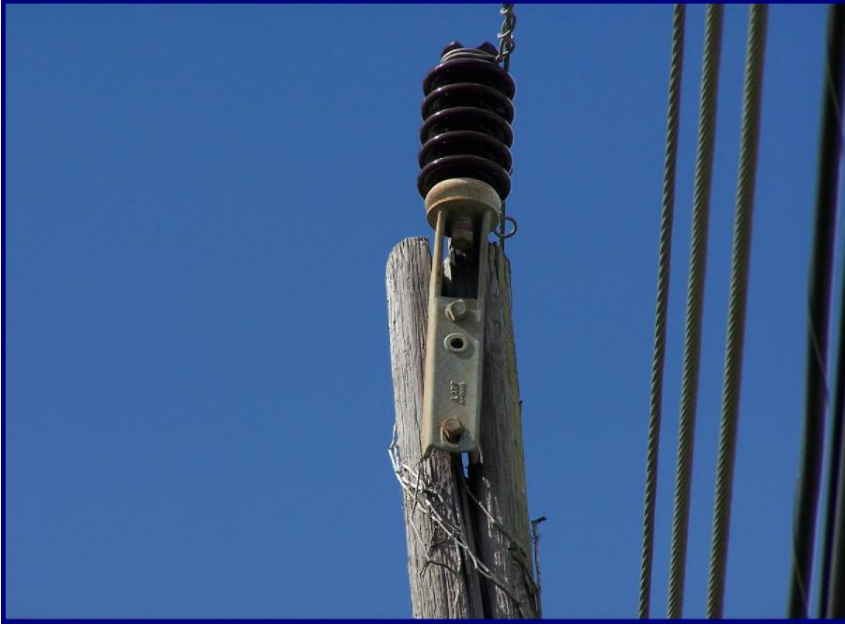
Poles with split tops that affect the integrity of through bolts or hardware and that do not have additional through bolts running perpendicular to the split (holding the split together) is recommended for replacement, regardless of ground line conditions.

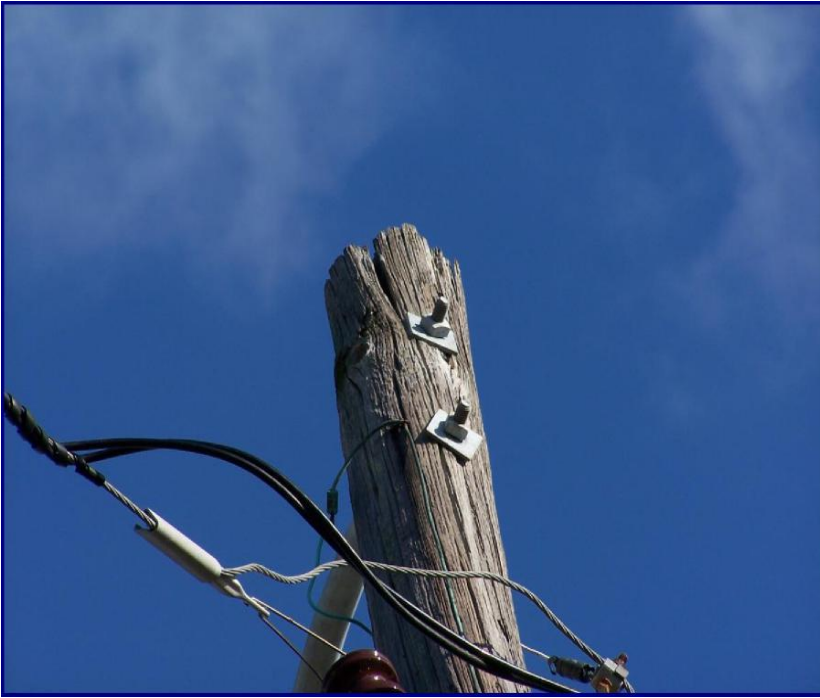
SPLIT TOPS:

Poles with split tops that do not affect through bolts or hardware integrity should be reported but should **not** be considered for replacement.

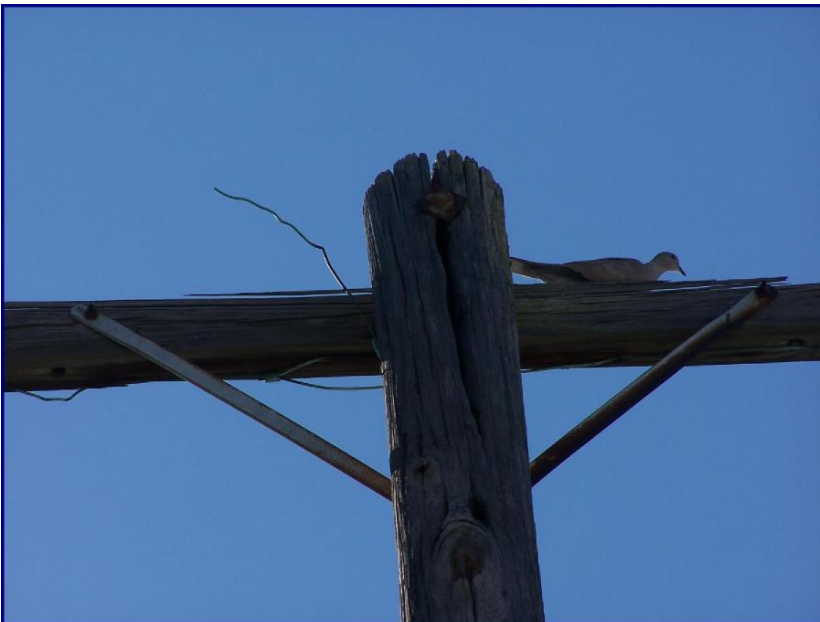
SPLIT TOPS:

Poles with split top with no through bolt running perpendicular to the split is recommended for replacement based on the pole top condition.

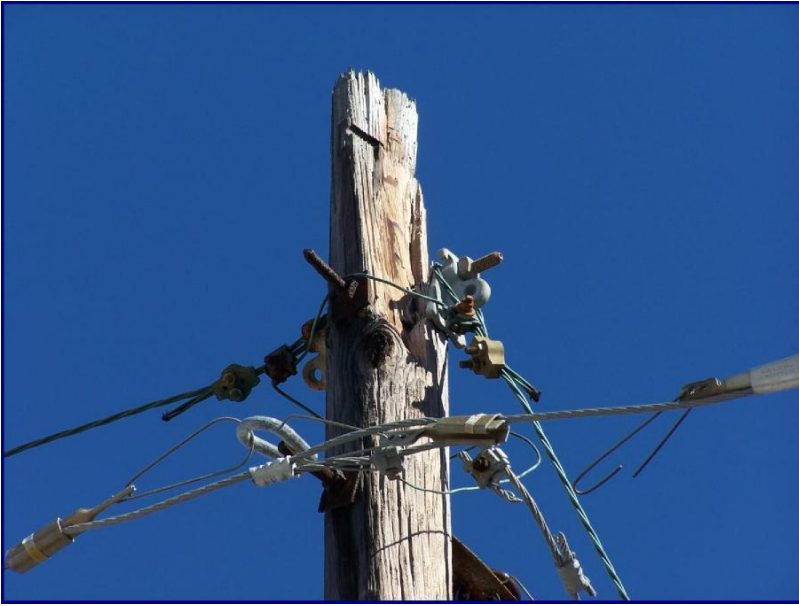
SPLIT TOPS:

Poles with top of the pole breaking off as the result of a split top and negatively impacting the hardware, failed pole visual inspection is recommended for replacement.

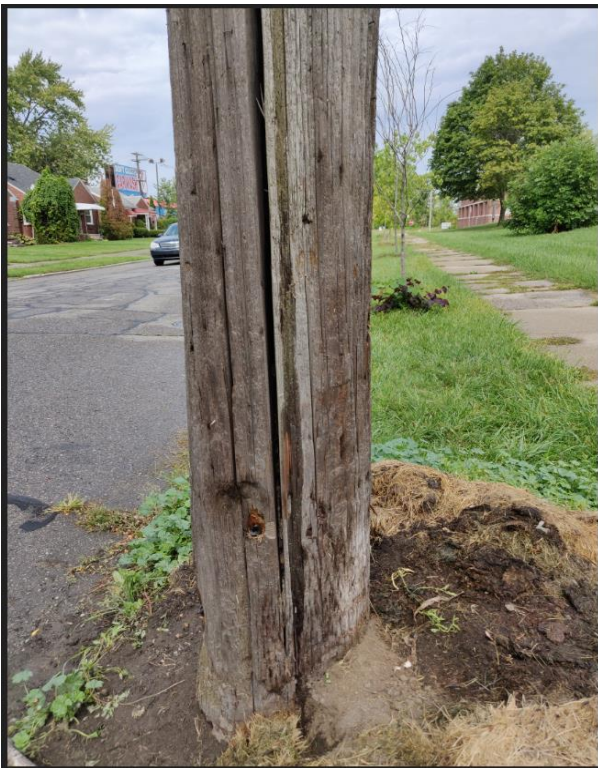
SPLIT POLE

Poles with deep and large cracks going from top to bottom of the pole, fails visual inspection and it is recommended for replacement

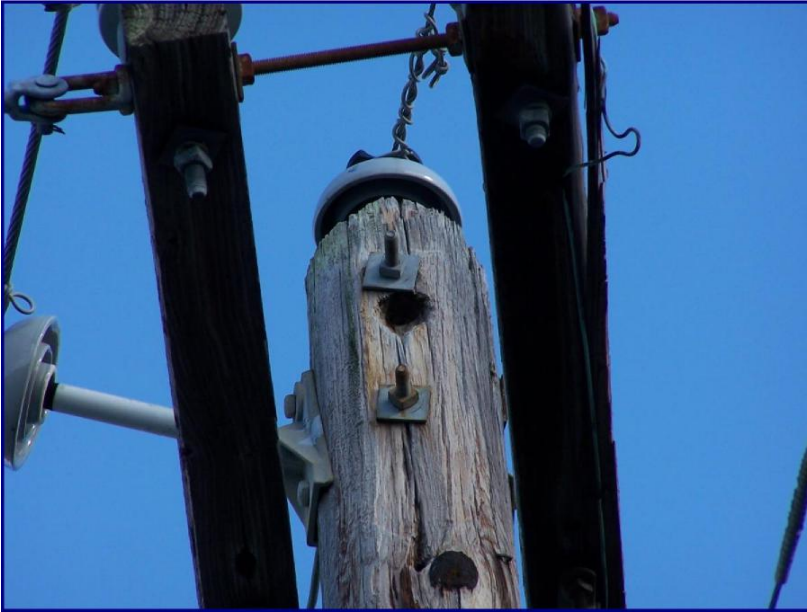
WOODPECKER HOLES:

Poles with woodpecker holes around bolt holes (peck out) and that do not affect the integrity of the hardware should not be considered for replacement based on the pole top condition.

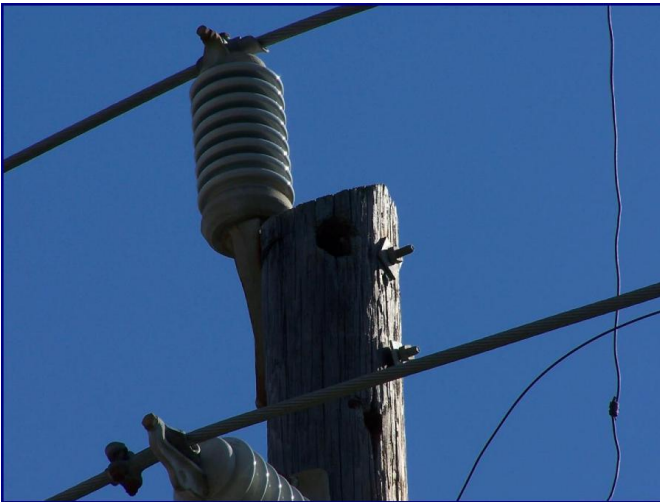
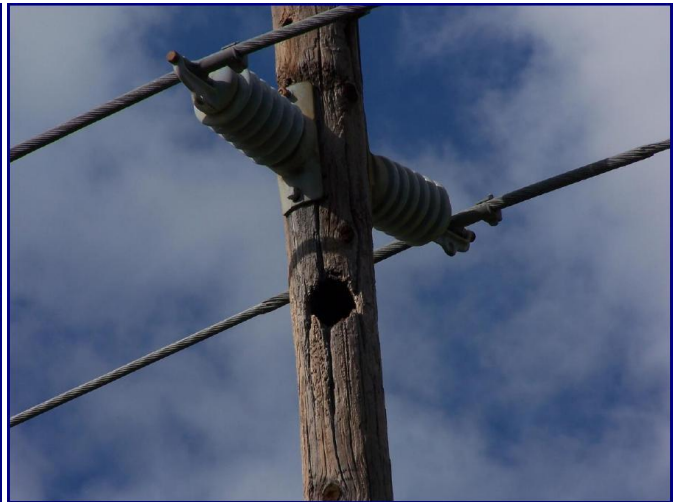
WOODPECKER HOLES:

Poles with woodpecker holes around or below the hardware that appear to be hollow or the back of the hole can not be determined are recommended for replacement.

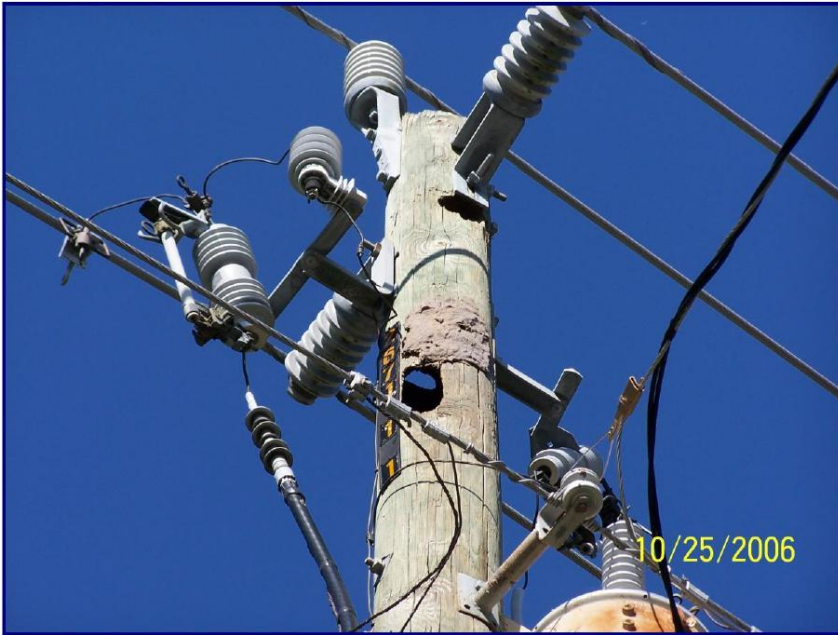
WOODPECKER HOLES:

Poles with woodpecker holes that are going through the pole are recommended for replacement.

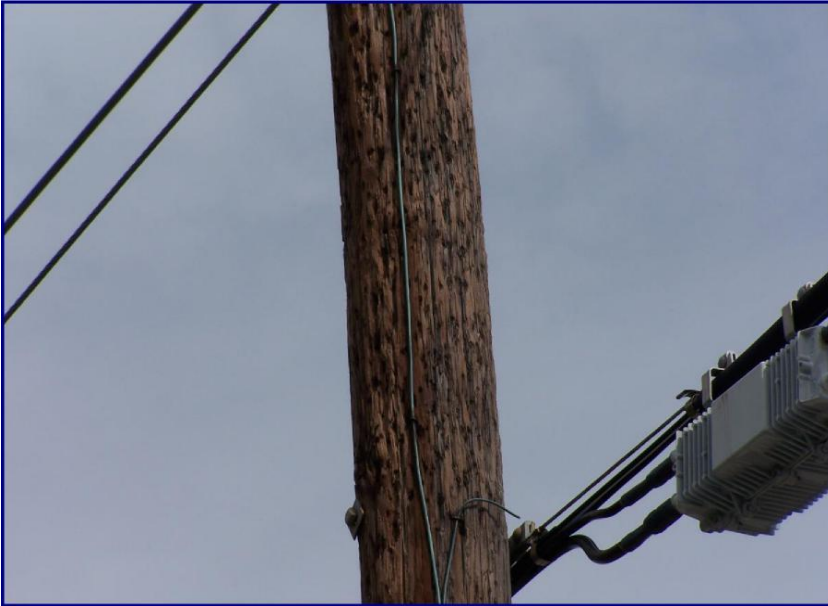
SPUR CUTS:

Pole with moderate damage as a result of spur cuts from excessive climbing should **not** be considered for replacement based solely on this condition. Spur cuts that are moderate should be noted under other pole conditions.

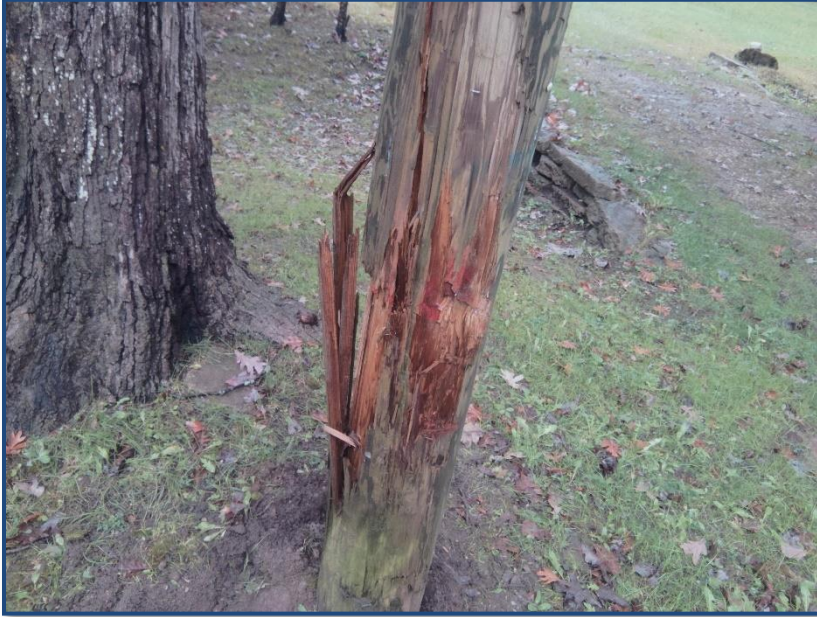
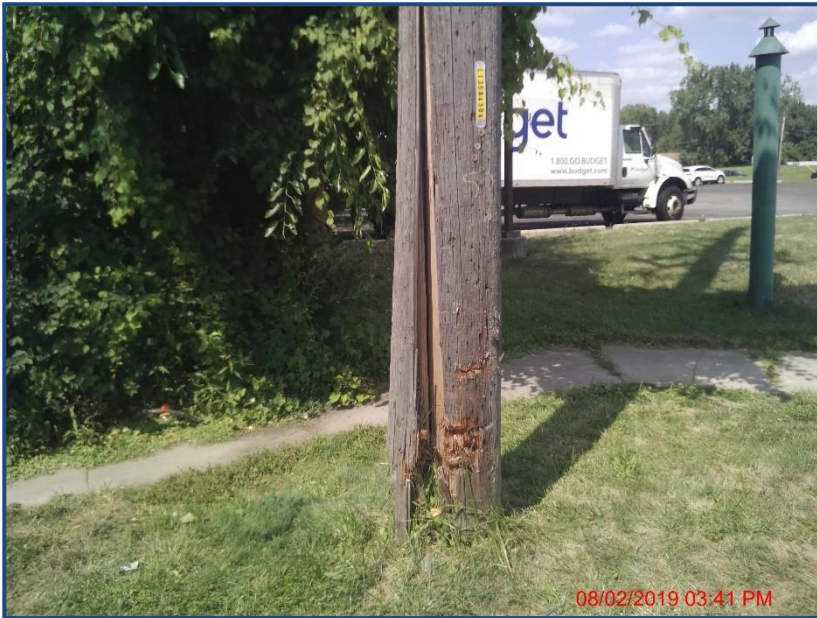
MECHANICAL DAMAGE:

Pole with moderate damage as a result of vehicles, non-environmental factors, or vandalism that are from the result of man-made forces from accidental or purposeful actions. Moderate mechanical damages can be defined as damages that will cause question of the structural integrity of the structure such as structure shell loss or large cracks. Damage that results in a minimum of 1 inch of the poles outer shell being removed should be considered for replacement.

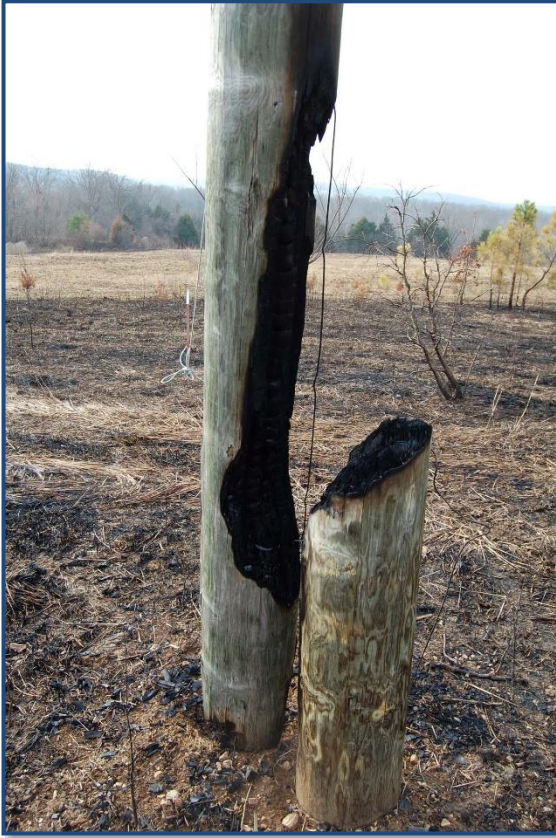
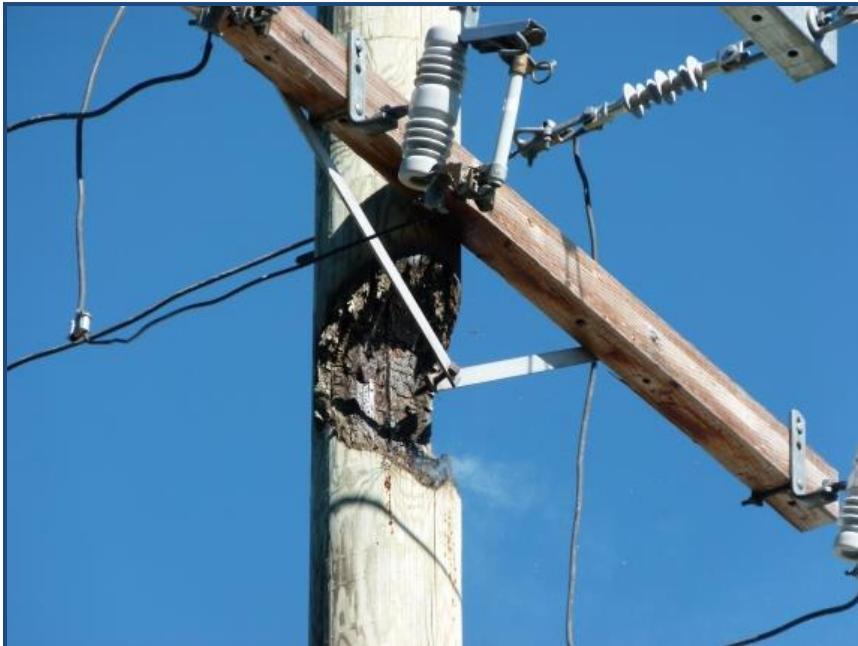
FIRE DAMAGE:

Pole with moderate damage as a result of equipment failures, environmental factors, or vandalism that are from the result of fire, lightning strikes, or set fires. Damage that results in a minimum of 1 inch of the poles outer shell being compromised should be considered for replacement.

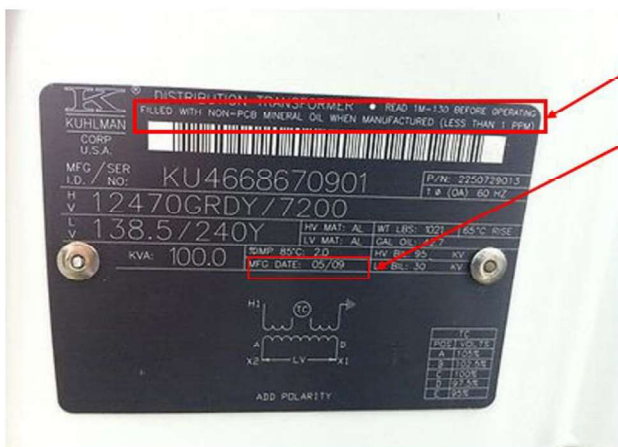
Newer units will indicate non-PCB verbiage and key manufacture moth/year

- Non-PCB verbiage ✓
- Manufacture date is 05/09, if it indicates beyond 01/80 it is PCB free ✓

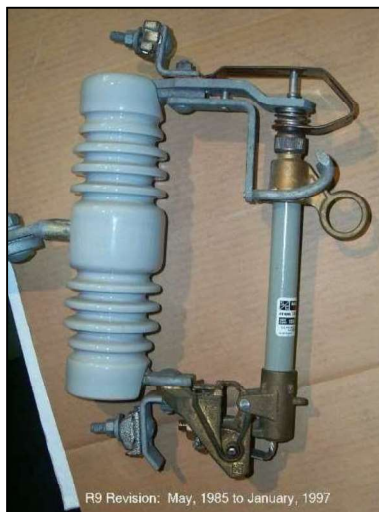
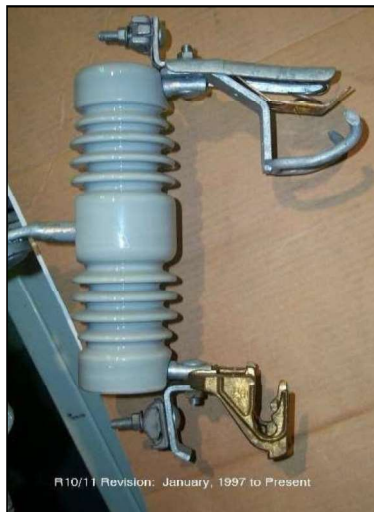
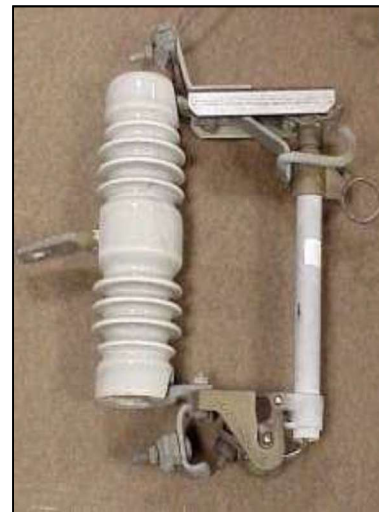
Porcelain Cutouts: S&C R9, R10, AB Chance Cutouts

All porcelain cutouts must be replaced; only polymer cutouts are the current standard. Polymer cutout should be replaced if the cutout is burnt, melted, and arcing. More reference on EB-2005-OH-05 / EB-2005-OH-05

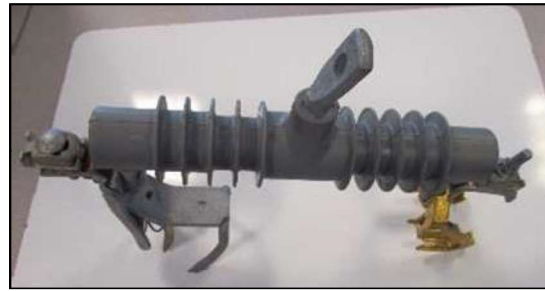
Acceptable S&C Electric Polymer Cutout

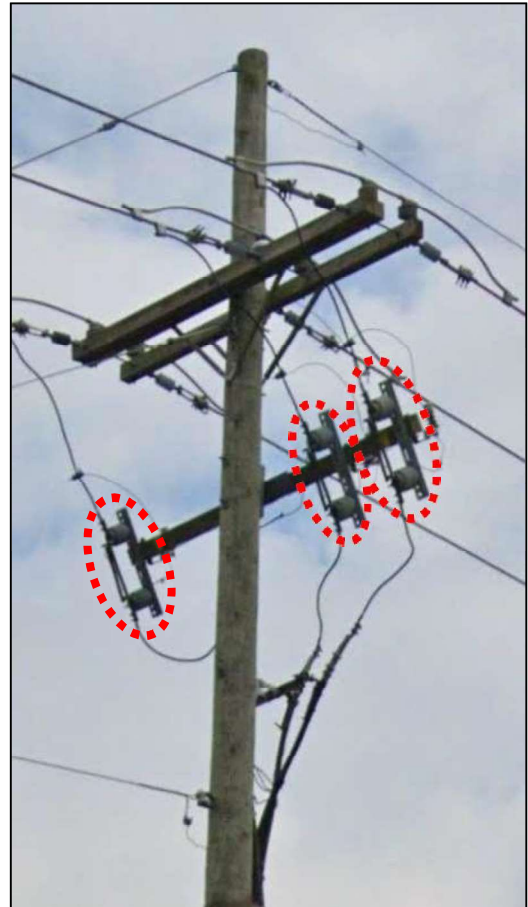
Acceptable Polymer Disconnect Switch

Location of Disconnect Switch

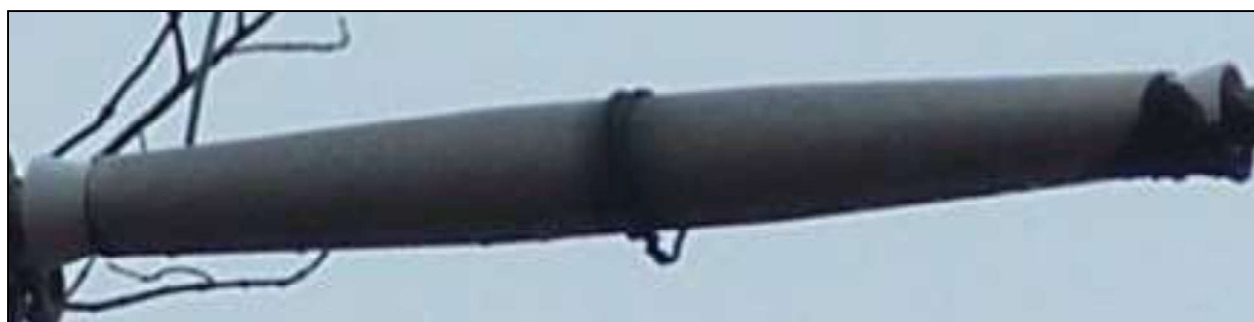
Any automatic sleeves must be replaced; the current standard is the compression sleeve. Compressionsleeves must be replaced if the conductor, on either side, has a broken wire. Reference EB-2014-OH-10

Automatic Sleeve to be reported.

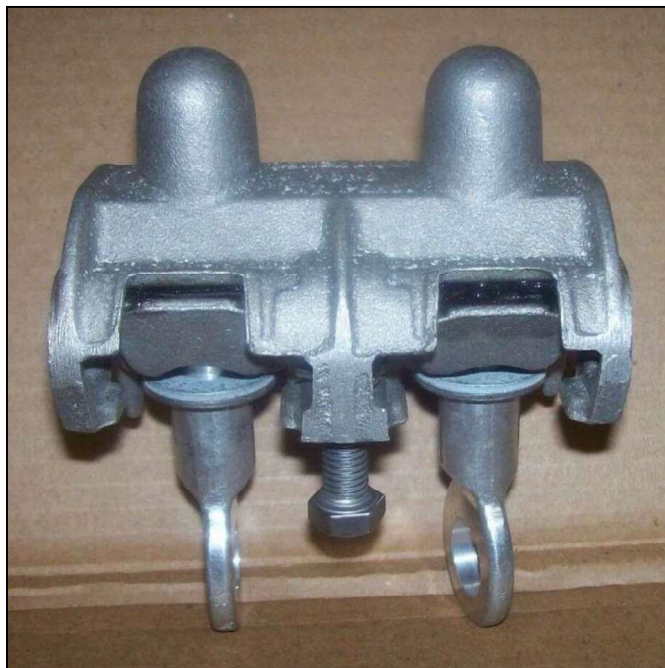
According to EB-95-OH-34 the Blackburn taps should be removed and replaced with an approved tap.

Blackburn Hot taps shall be reported and replaced

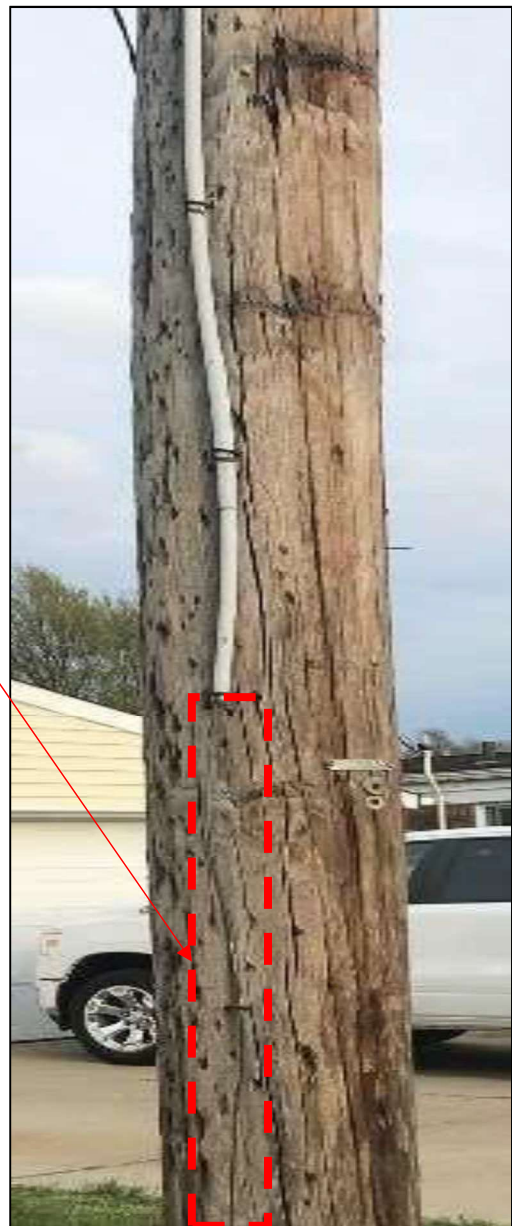
Defective Ground Wire (non-continuous)

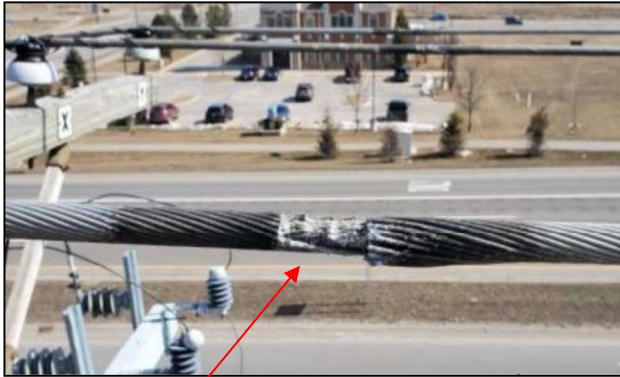
All smart fault Indicators that show signs of burning on either the conductor wire or sensor needs to be reported and replaced. Sensor will typically show signs of damage on the duckbill and eyebolt. Attached are photos of the burned conductors and sensors.

Burned Conductor

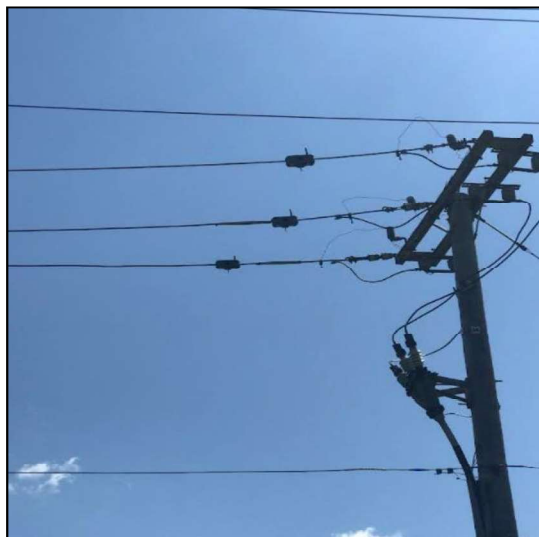
Location of the Smart Fault Indicators

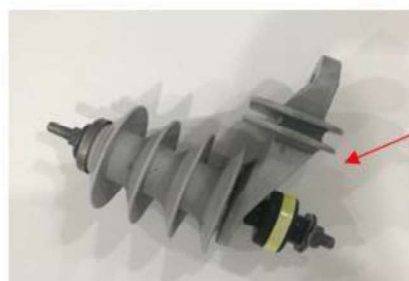
Side View of Arrester

Vari-Gap Arrester

Arresters that have a blown isolator must be replaced. The arrester should be replaced if melted, and burnt, arcing. All Vari-Gap designed arresters must be replaced broken or unbroken. The Vari-Gap arresters stopped being installed in 2002.

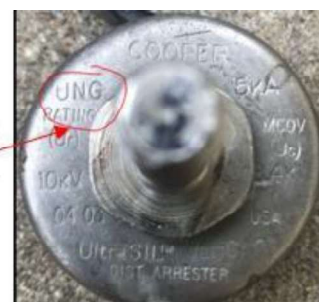
Top View of Arrester

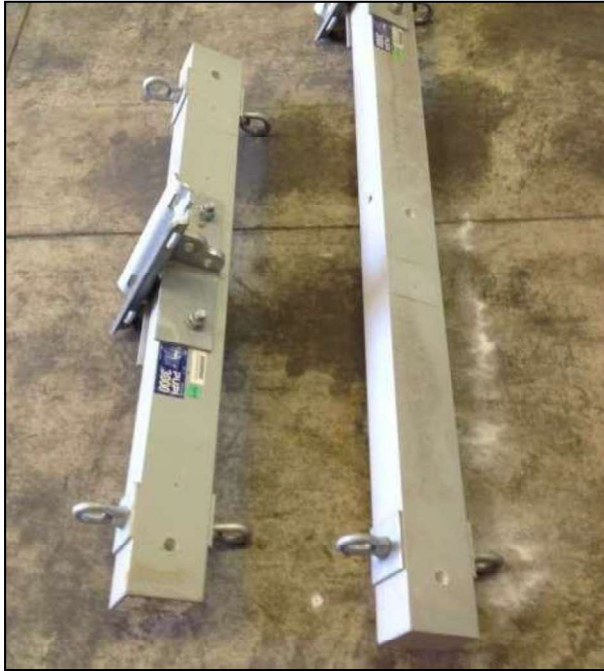
Acceptable Fiberglass Cross-arm

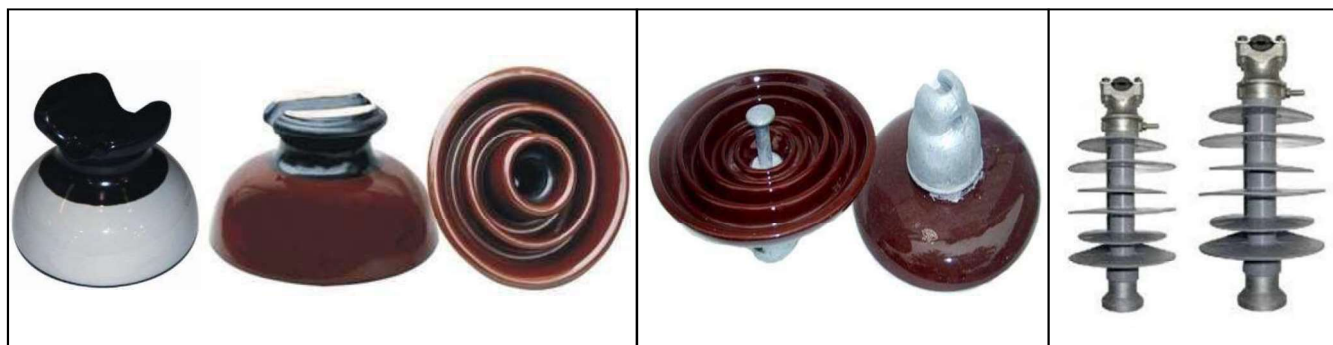
Acceptable F-neck, Disc, and Line-Post

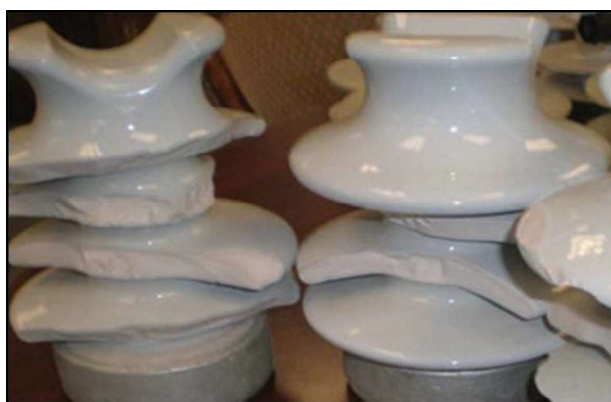
Defective Line-Post Insulator

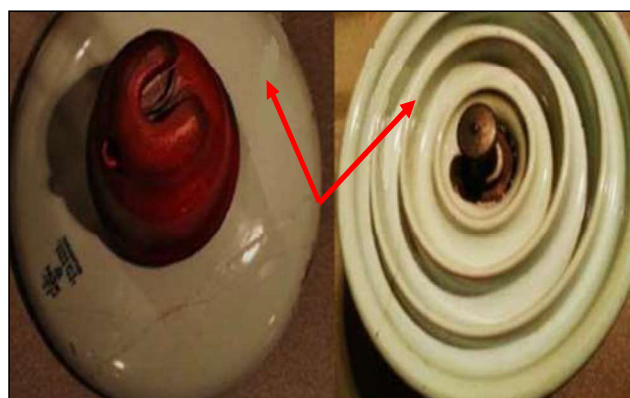
Defective Disc

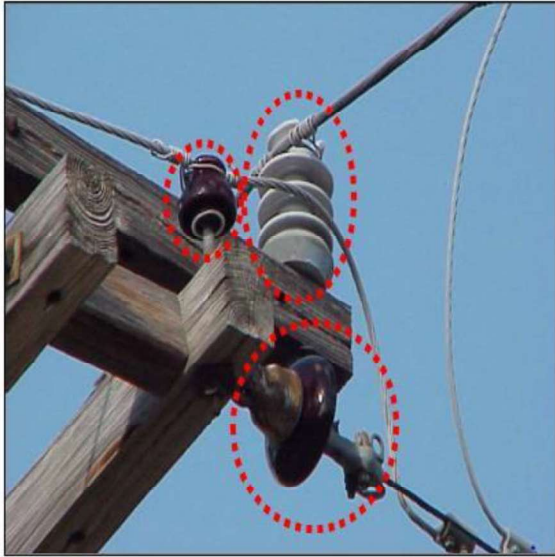
Insulator locations

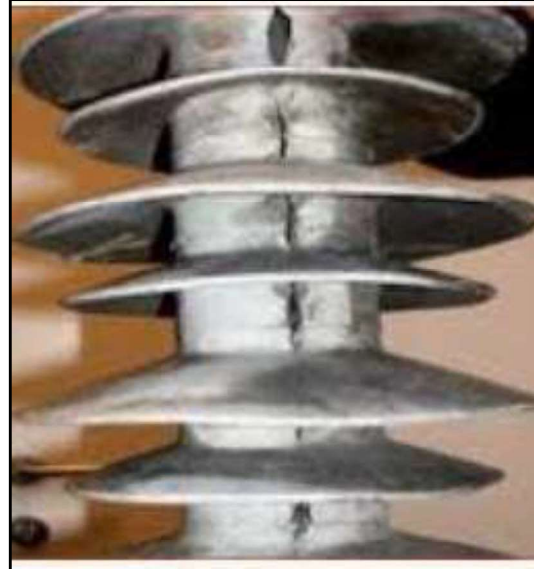
Damaged insulator

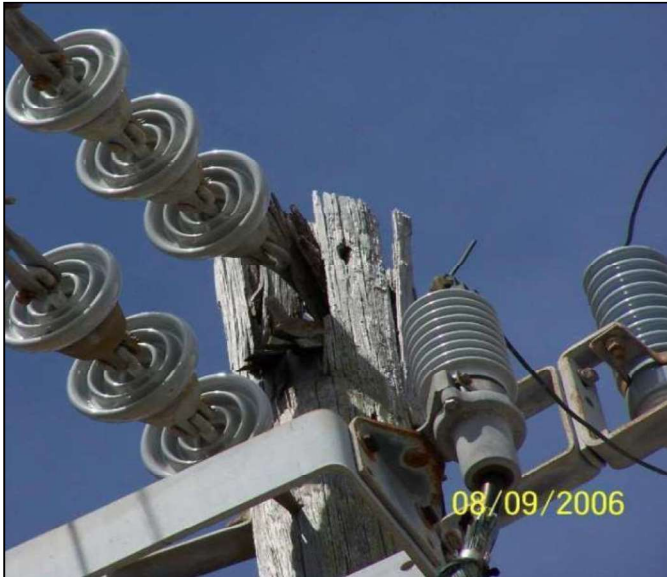
Pole tops that impact the integrity of any hardware and do not have a through bolt, must be replaced.

Defective Pole Top

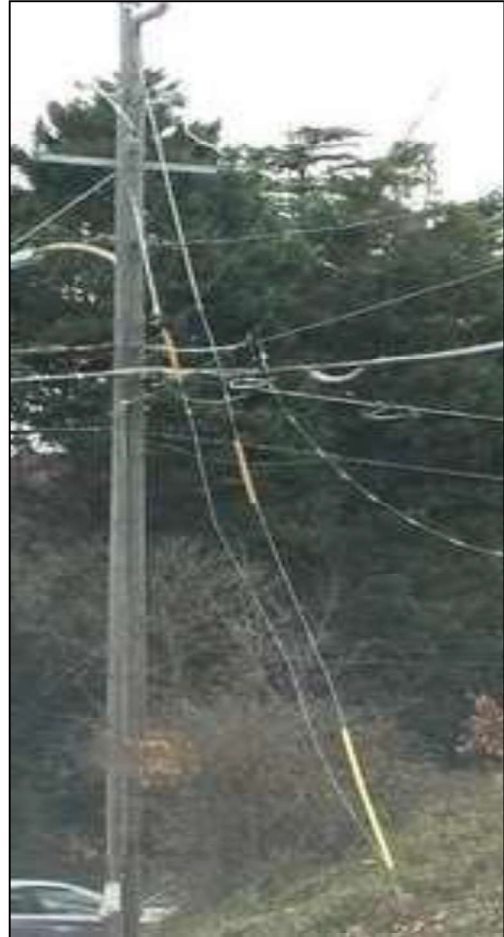
Guy wires: To be reported if broken strands are observed or it is loose. **Johnny Ball:** To be reported if it's broken or disconnected.

Defective Guy Wire

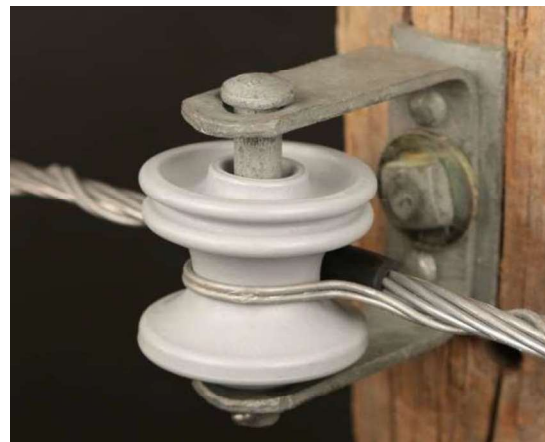
Acceptable Neutral Spool Assembly

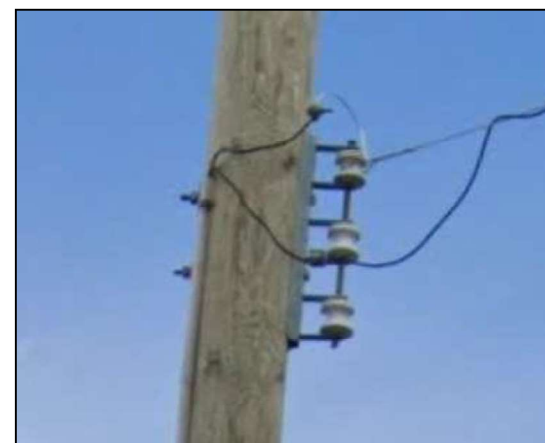
Acceptable Spool Rack

If any of the elements contained in the picture is broken including porcelain insulators, rack, or bolts should be reported

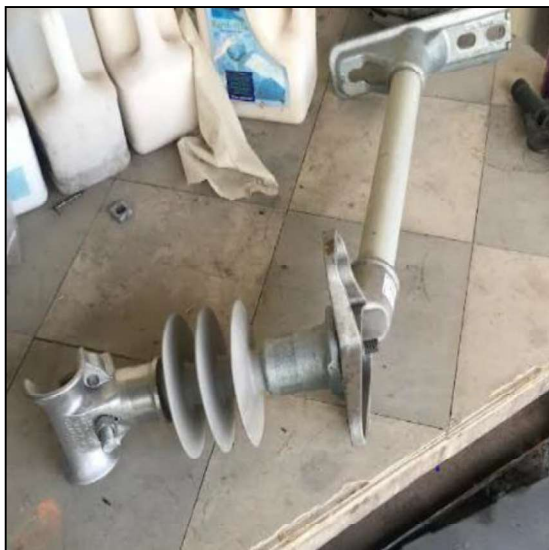
Single Phase Fiberglass Bracket with Insulator

Fiberglass brackets may experience discoloration, warping, delamination, blistering, and cracking. Attached below are photos of the different fiberglass brackets that out in the field.

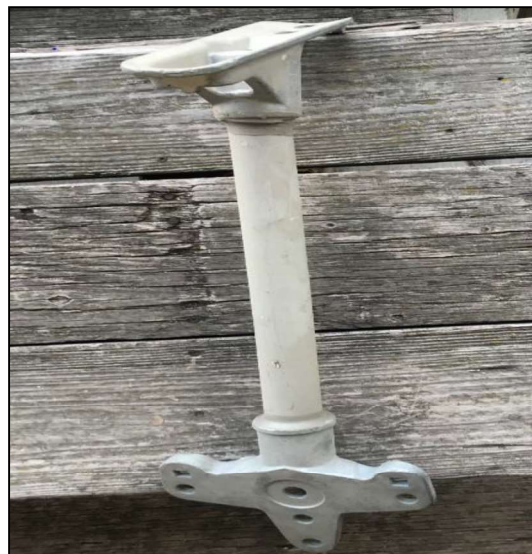
Single Phase Fiberglass Bracket

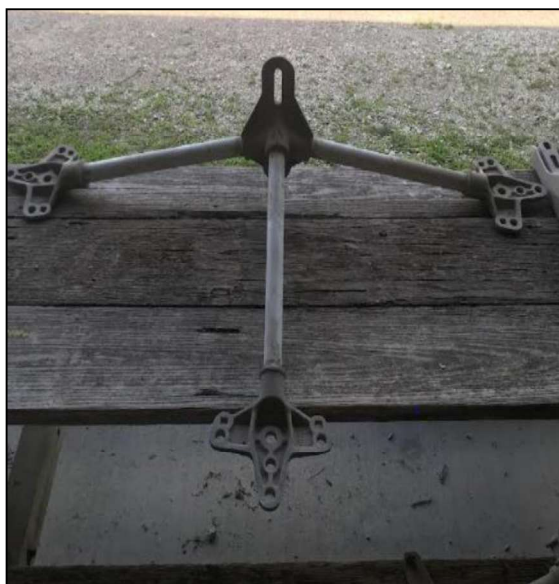
Three Phase Equipment Fiberglass Bracket

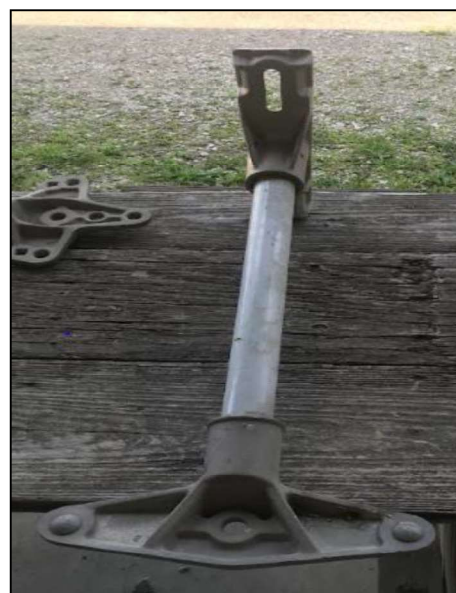
Single Phase Fiberglass Bracket

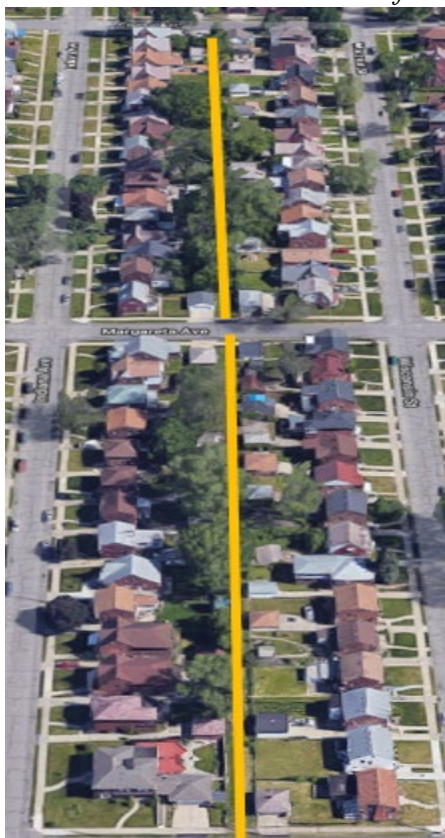
Figure 1: Two City Blocks for Rear-Lot Overhead to Rear-Lot URD Conversion
Yellow Lines – URD cable loop / Dashed Red Lines – Secondary / Square – Pad-mount Transformers / Circles – Pedestals

*Two Block Scope of the Appoline Pilot
Yellow Lines Indicate where the URD is installed (rear-lot)*

Figure 1 illustrates the scope of the pilot project. Appoline is a 4.8kV circuit that will be converted to 13.2kV at some point in the future, therefore the pilot project is being constructed to the higher

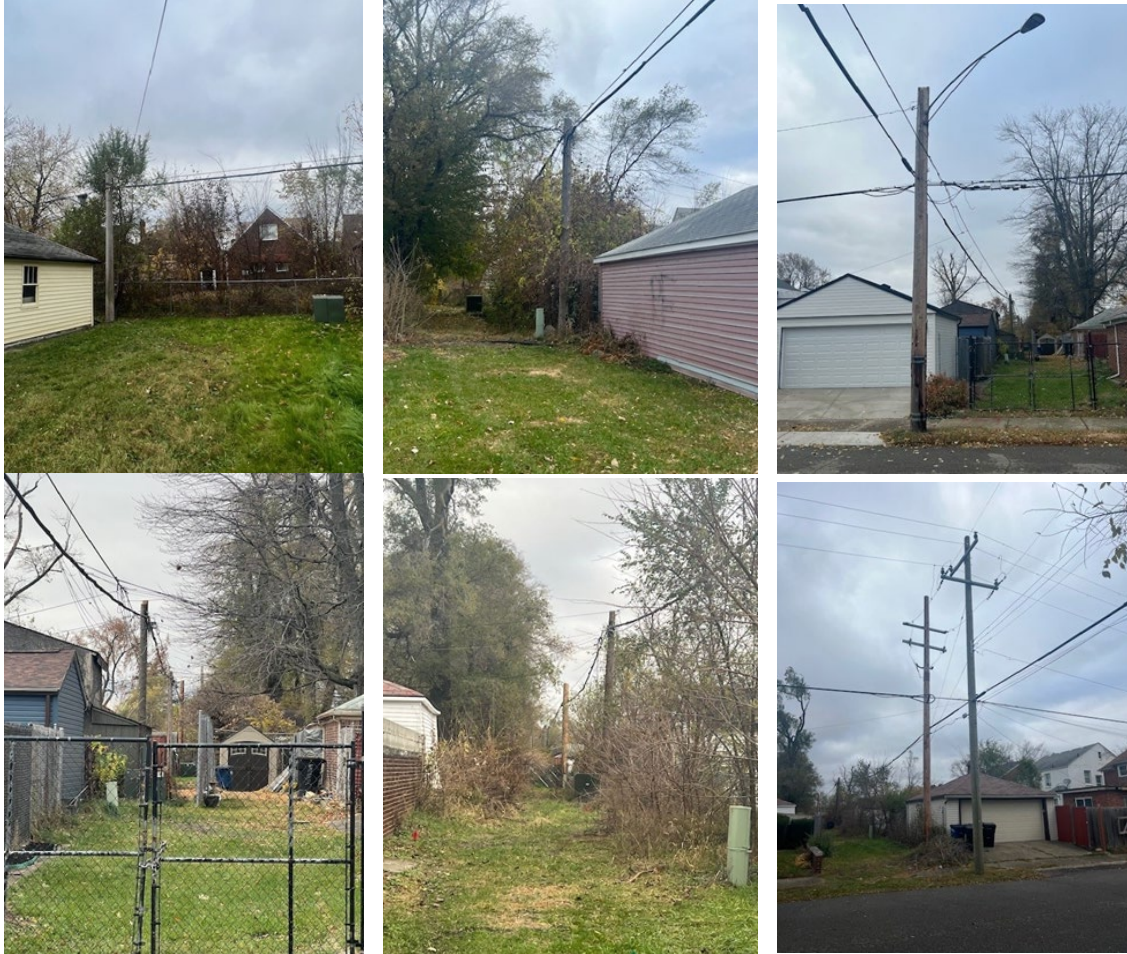
Appoline construction complete

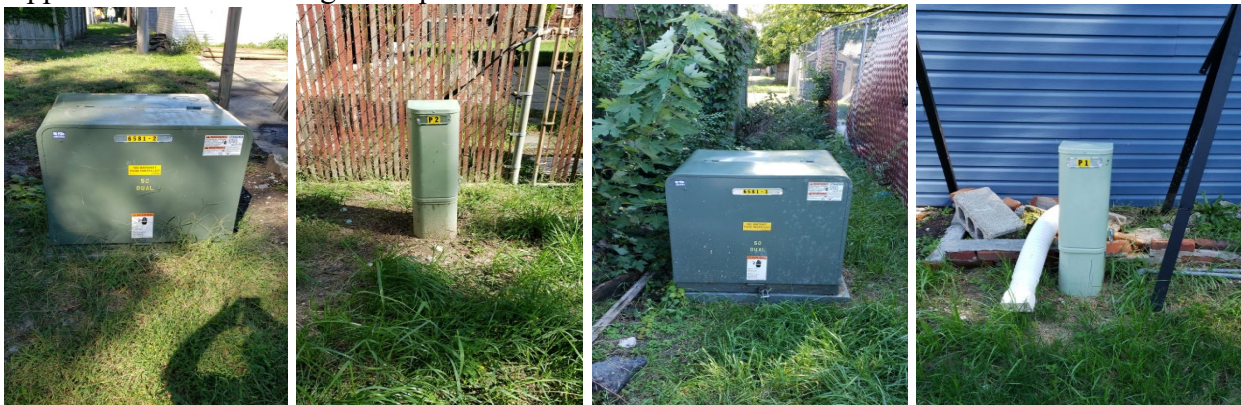
Appoline installed underground pedestals and transformers

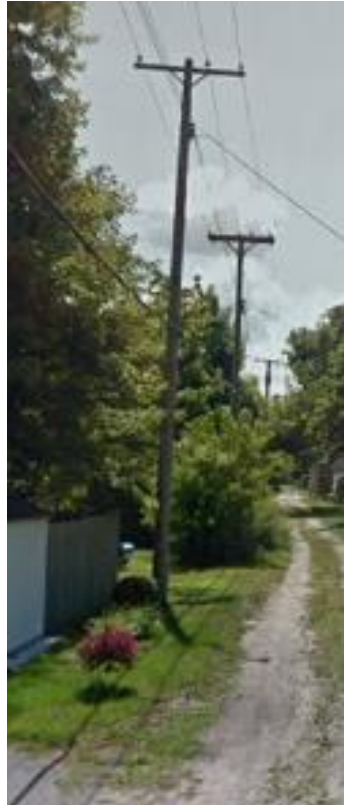
Construction of the three phase leads are similar across voltage type, and may be either in the rear lot or near road right of way; 4.8kV poles are often shorter and require less clearance

4.8kV System

Rear Lot

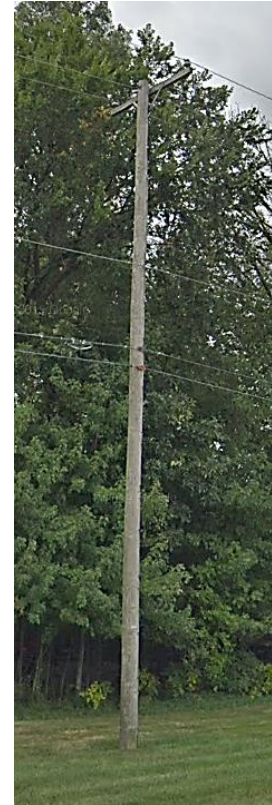
13.2kV System

Rear Lot

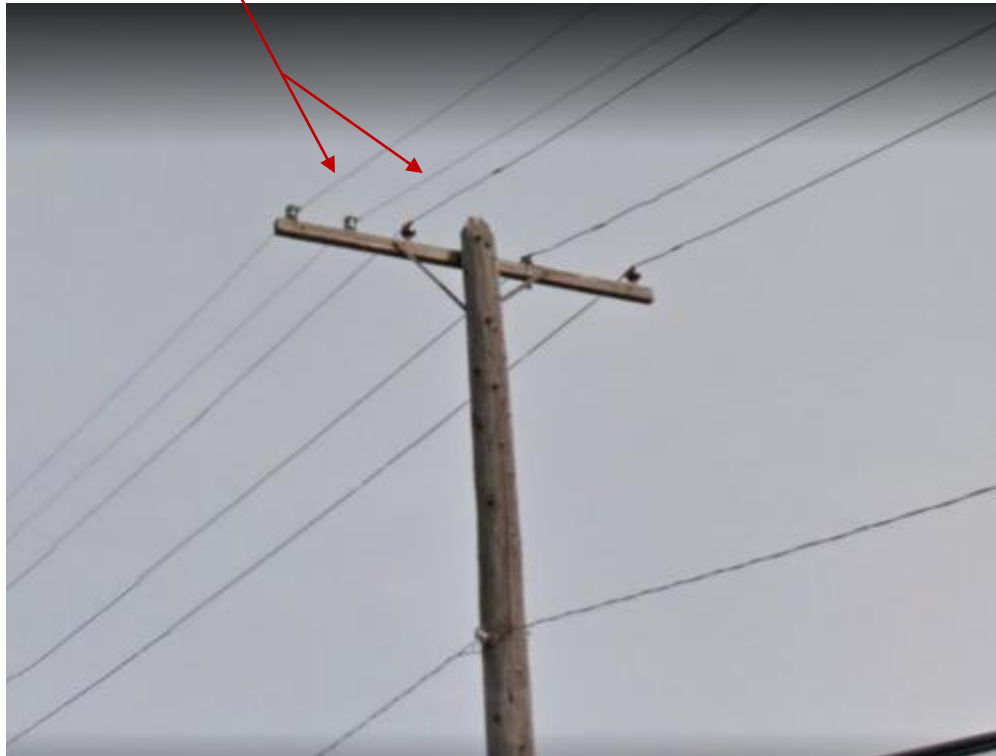
The Public Lighting Department (PLD) Arc Wire System was used to supply electricity to arc-type streetlamps and share utility poles with DTE Electric distribution

- Those streetlamps are no longer used, but large amounts of arc wires are still attached to utility poles
- The abandoned wire poses a risk if it becomes energized by making contact with DTE facilities
- In 2017, we estimated that there were approximately 1,300 miles of DPLD arc wire that was intermittently co-located among DTE Electric's 2,400 miles
- An average DTE Electric circuit in the City of Detroit is expected to have arc wire co-located on about 50% of the poles
