RE: In the matter of the Application of **DTE ELECTRIC COMPANY** for authority to increase its rates, amend its rate schedules and rules governing the distribution and supply of electric energy, and for miscellaneous accounting authority
MPSC Case No. U-21534

WOOD POLE MAINTENANCE SPECIFICATION

Engineering Standards Group

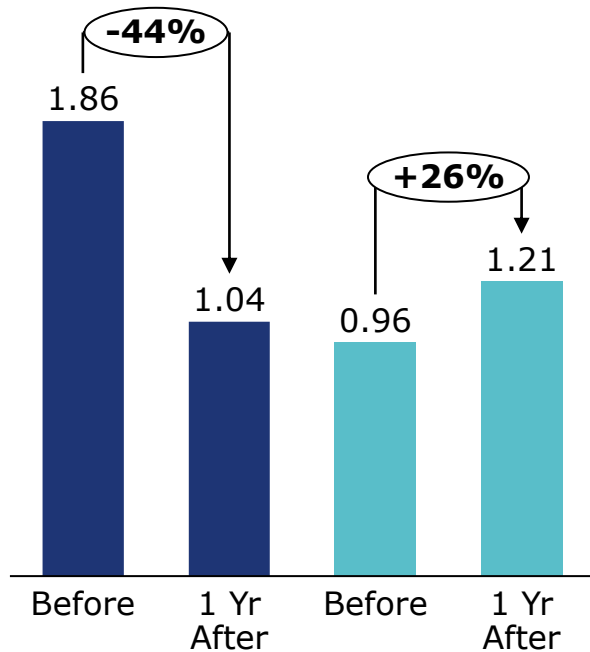
All Weather SAIFI

Performance of circuits addressed by the 4.8kV Hardening program have seen significant improvements in SAIFI, SAIDI ex-MEDs, and wire down events

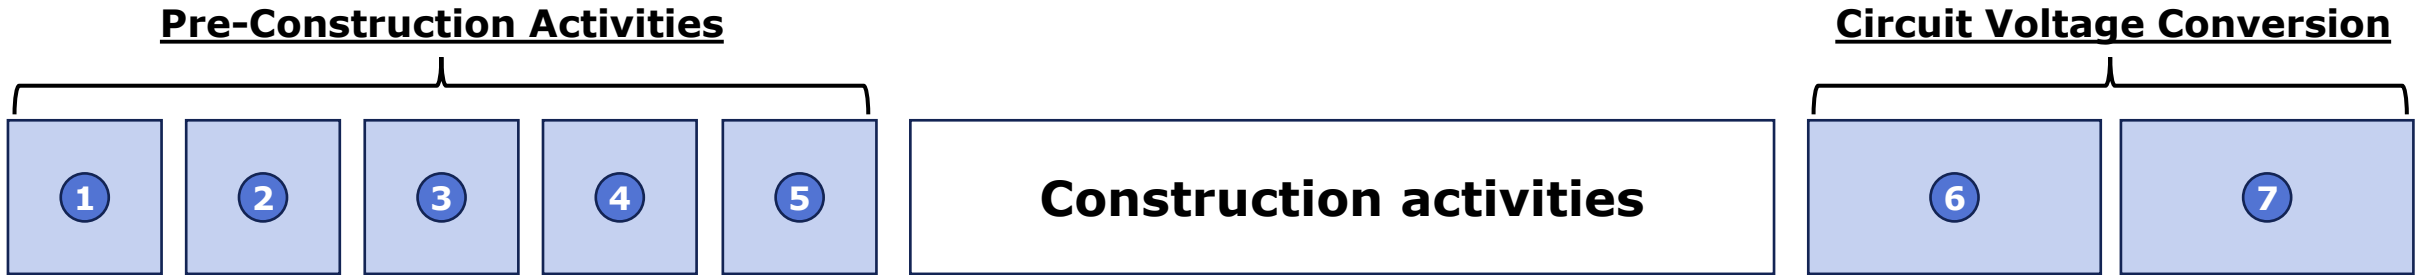
In addition to all the construction work that conversion entails, there are a significant number of challenging activities that must occur to complete the rebuild and voltage conversion of a circuit

- 1 **Property acquisition** can be a long process to identify and purchase the location
- 2 **Permitting and approvals** for easements and environmental clearances for new circuits often have long time horizons
- 3 **Interconnection with ITC** can be lengthy requiring studies and approvals through MISO
- 4 **Customer Communication and Outreach** efforts can be extensive when new construction differs from existing facilities

- 5 **Establishing new circuits** requires significant underground work from the substation impacting adjacent public roads and property
- 6 **Weather constraints** impact the timing of customer shutdowns as they are typically performed in weather above 40 degrees
- 7 **Large scale coordination and overhead resources** are required to change each distribution transformer to the higher voltage simultaneously

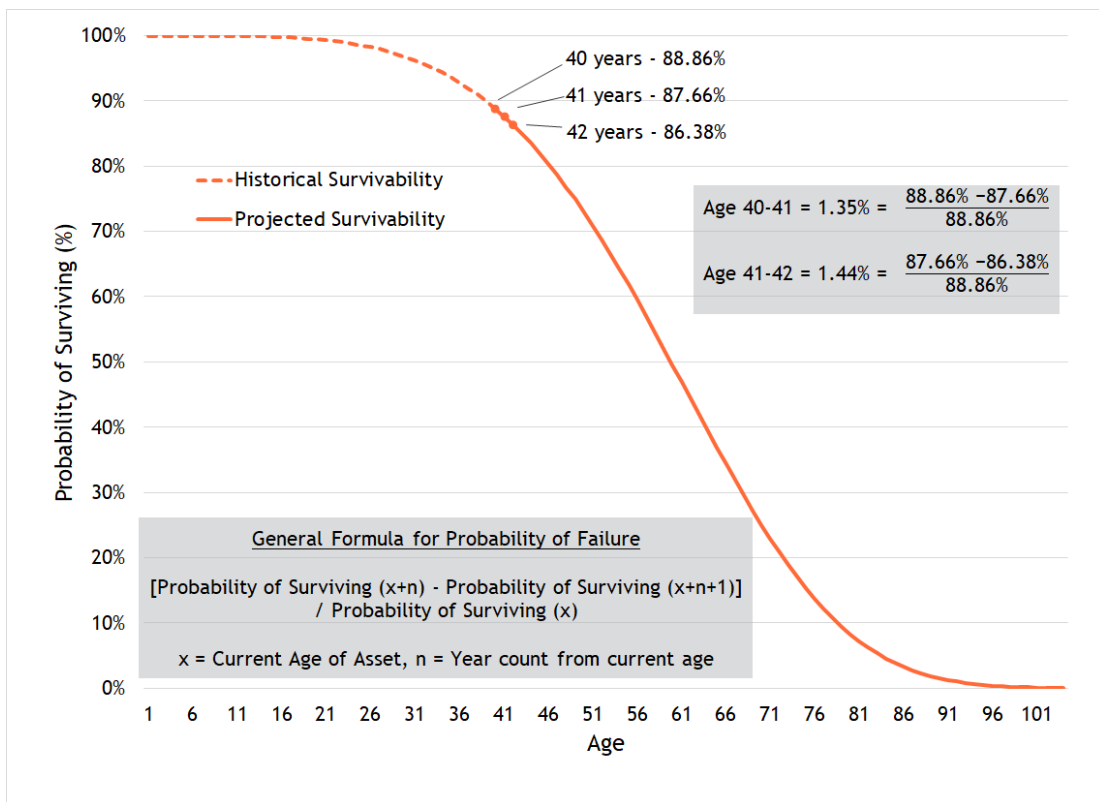
Figure 4-2 Annual Probability of Failure Example: 40-Year-Old Wood Pole

The survivor curves are leveraged to forecast an asset’s annual probability of failure given the asset’s age. Using the wood pole asset as an example, Figure 4-2 shows the approach to calculate the annual probability for a 40-year-old wood pole asset to fail between age 40 and age 41 (i.e., 1.35%) and fail between age 41 and age 42 (i.e., 1.44%). This calculation produces a probability density function where the total probability of failure over time is 100 percent, indicating the asset at the given age (i.e., survived till this age) will nonetheless fail in the future but at different probabilities over time.

Figure 4-3 shows the annual probability of failure, or the probability density functions, for a range of wood pole ages based on the mathematical approach shown in Figure 4-2. The figure shows that as assets get older, their 100% total failure probabilities are distributed over fewer years. Notably, the dotted black curve, by mathematical formulas, illustrates the accelerating increase in an asset’s ‘next year’ probability of failure as it moves further along its survivor curve (See “Pole” survivor curve in Figure 4-1).
